Evaluation of long term degradation process of monocrystalline Si photovoltaic panels

Abstract. The paper focuses on evaluation of long time degradation process of the oldest grid-on operated photovoltaic system in Czech Republic.

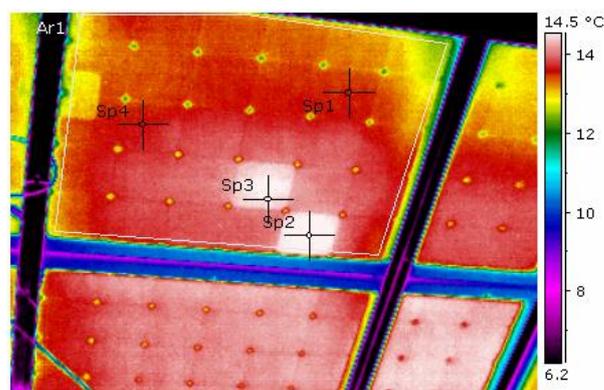
Fig. 2. Sample thermogram of panel 84 (2013)

Sample thermogram of the first defective panel (no. 84) from 2013 is demonstrated on Fig. 2. Defective cells in string 4 are evident. Thermograms from 2014 – 2018 are identical.

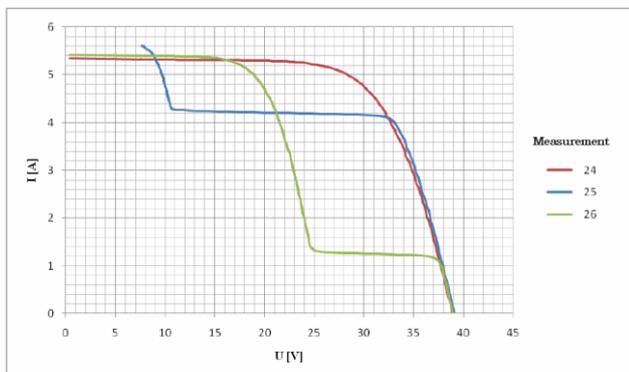
Fig. 4. Sample VA characteristics of panels 83, 84 and 141

Comparison of VA characteristics between healthy and defective panels is demonstrated on Fig. 4. Particular data

are summarized in Table III. Measurement 24 shows healthy panel (panel 1), while measurements 25 and 26 show defective panels (panel 84 and 141).

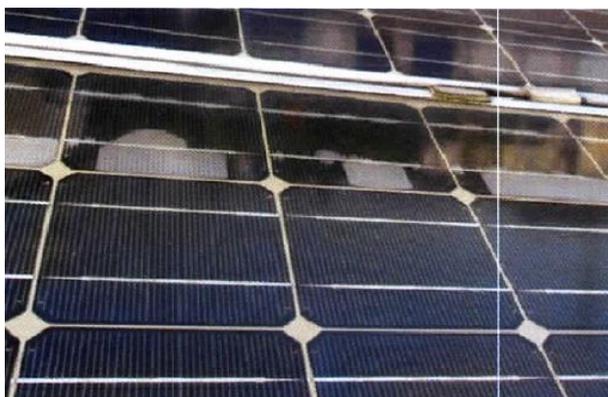
Fig. 5. Sample of delamination and cell degradation (panel 34)

Sample of strong delamination (white areas) and massive cell degradation (dark cells) is demonstrated on Fig. 5. Both defects (panel 34) are evident in the middle of the picture. 116 panels showed cell degradation in similar size or different type of defect from Table II.

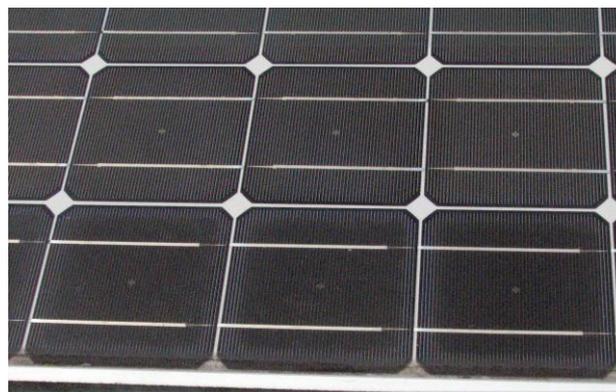
Fig. 6. Sample of the hotspot (panel 51)

Material degradation of particular cells in most cases of 117 affected panels is detected not on a single defective cell but on certain amount of defective cells. Affected cells usually create some pattern as shown on Fig. 6. This dependency indicates some technological problems during the fabrication process. The most presumable reason is the homogeneity of the raw silicon material or the homogeneity of the gaseous environment during the passivation process [1].

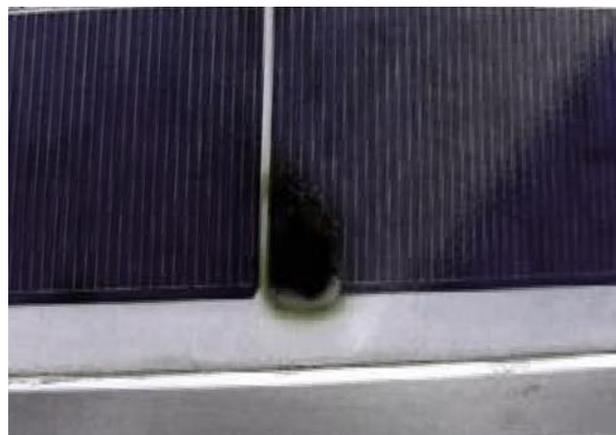
Fig. 7. Sample of the hotspot (panel 67)

Typical hotspot was detected on 37 particular panels. Sample of this phenomenon (panel 67) is presented on Fig. 7.

Typical behaviour is overheated area with broken conductors or collectors on the frontal side. Also thermal degradation of EVA on front and back side occurs, if the malfunction lasts longer time [3, 4].

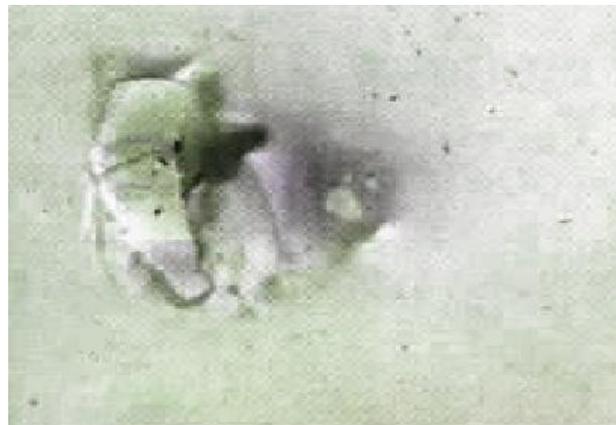
Fig. 8. Sample of degraded backside EVA (panel 81)

Very unpleasant situation is a rupture of the backside EVA or the frontal glazing. The panel is opened for humidity, what results in fatal malfunction of the panel. Sample of degraded backside EVA is presented on Fig. 8. (panel 81).

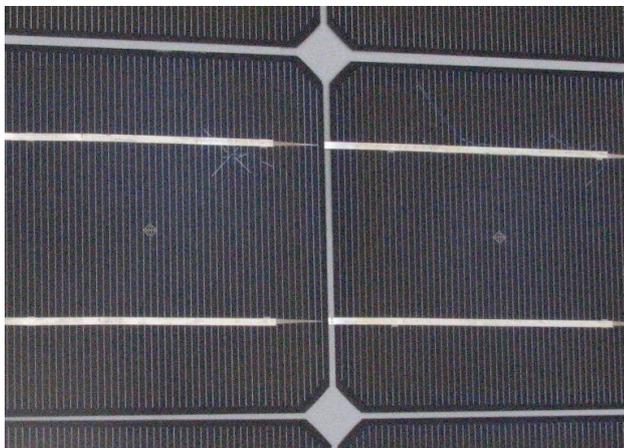
Fig. 9. Sample of microcrack (panel 104)

36 new particular microcracks were identified during the 2019/2020 analysis. Two typical examples of the microcrack are presented on Fig. 9 (panel 104). This panel is unique, because it is the only panel with more than 1 cell with a microcrack. The right cell is an example of star shaped microcrack while the left one is a sample of linear microcrack.

The microcrack is the result of the local non-homogeneity and thermal stress. Typical behaviour of this malfunction is a gradually expanding crack that slowly parts the cell in one or more direction. The edges initiate other thermal stress and degradation of the whole structure [1, 3, 6].

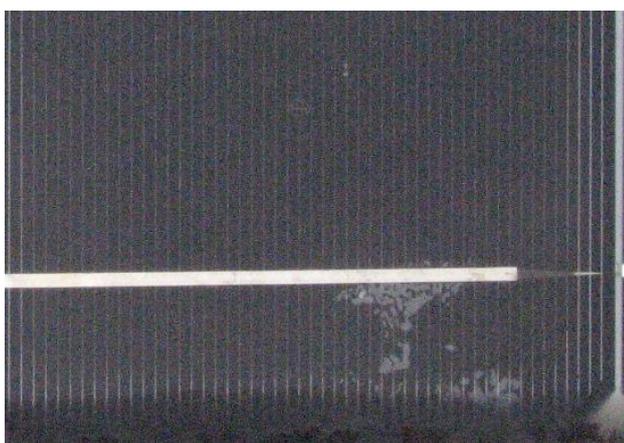
Fig. 10. Sample of snail traces (panel 88)

Another problem with the homogeneity of the fabrication process or the raw material can be observed as so called snail traces. These symptoms can be found on the front side of affected cell as demonstrated on Fig. 10. Panel 88 is good example of 18 detected malfunctions.

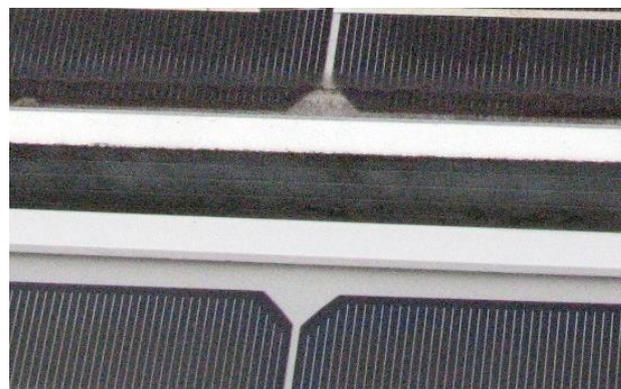
Fig. 11. Example of aerial pollution and corrosion (panel 21)

Almost all of 192 panels show significant traces of massive aerial pollution accompanied with the degradation of covering material. These traces can be found on the bottom edge of the panels. Metal frame in this part of the panel restrains attached pollutants to be completely washed out from the surface during natural rains, the pollutants start to create a layer that slowly becomes solid and sturdy.

Not only physical stress but also chemical processes degrade the surface. The environment becomes slowly pleasant for micro-organisms and biological corrosion is started.

Typical example of this phenomenon on panel 21 is illustrated on Fig. 11 (upper panel). The pollution creates a stripe approximately 1 cm high. Also the corrosion of the aluminium frame are evident on the upper panel.

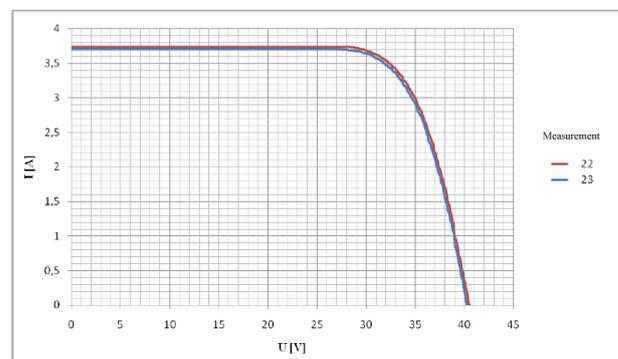
Fig. 12. Sample VA characteristics of panels 87 and 88

Example of this malfunction type is demonstrated on Fig. 12. Reference VA characteristic of healthy panel shows measurement 22, while number 23 presents the panel 88 affected with the snail trace. This defect covers approximately 2 % of the area on 6th cell in the 1st string.

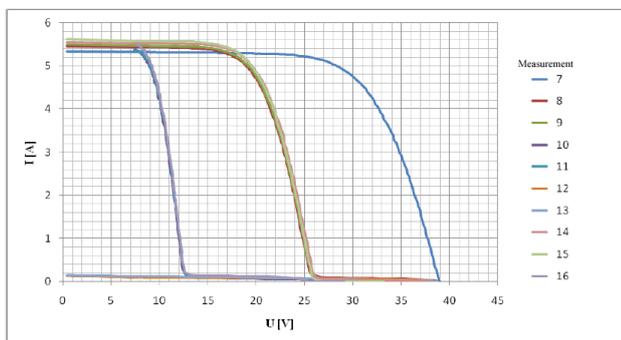
Fig. 13. Sample VA characteristics (measurements 7 – 16)

All other malfunctions (hotspot, microcrack, metalisation defect etc.) have more significant impact on the VA characteristic. This set personate 126 cases (29,2 %). Fig. 13 shows samples of this behaviour. Reference VA characteristic of healthy panel shows measurement 7. Cases 8 and 9 demonstrate influence of the hotspot on one sole cell, while measurements 10 and 11 illustrate the same malfunction but on 2 cells connected into independent strings. Examples 12 and 13 show particular microcracks of the star shape while number 14 presents linear microcrack. Curves 15 and 16 demonstrate defective bus connections in particular strings.

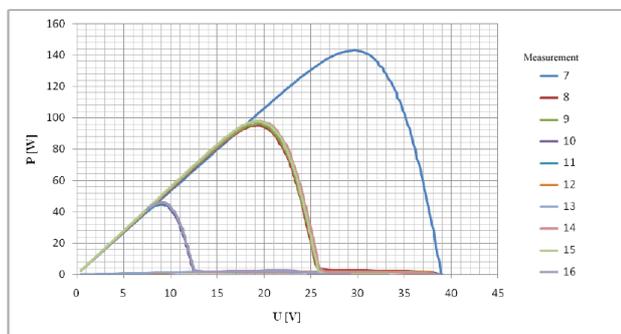
Fig. 14. Sample power characteristics (measurements 7 – 16)

Direct impact of presented malfunctions on generated energy is demonstrated on Fig. 14 where power characteristics of affected panels are compared. Serious change of generated power and MPP position is evident.
