Solar Panels for Auger Southern Observatory: “SPIDERSHADOWS”

Abstract. During the winter of 2009, technicians inform about how during a visual inspection they detect failures in the surface of different solar panels. The inspection was not casual, but due to problems with the level of charge of the batteries. Because of the aspect on the failure we will name it “spiders” (*arañitas*). But other anomalies, associated to the expected ageing, have been observed, like panels with blued cells, browed surface and others. In the present note, we will describe each of the observed failures, their possible causes and their effect on the solar panel operation. The full data sample we used has been obtained either on dedicated laboratory test (PAO, USC, CIEMAT) or by direct measurement in the field.

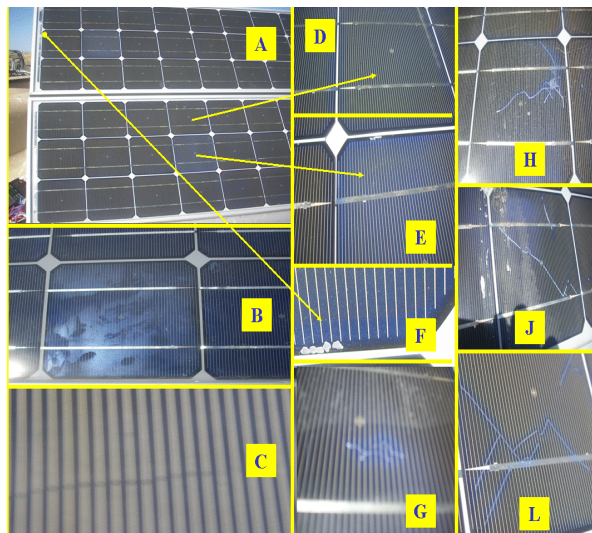
Fig. 1. Various photographs of a PAO's with the most common defects observed.

A. Laviform cells (figure 1-B).

Comprise anomalies in which the solar cell surface seems to be melted (in blue) like lava does. Never reported in the bibliography

B. Brown cells (figure 1-D)

Photovoltaic module's cells presenting a brown shade in its surface. It is associated to deterioration of the epoxy resins with the irradiation and take part of the standard expected ageing of the solar panel.

C. Blue cells (figure 1-E).

Photovoltaic module's cells presenting a blue shade in its surface. Normally it affects the cells with less production which induces an increase of the cell temperature.

D. Metal excess on the shields (figure 1-F).

Normally without any consequence.

Presence of some evident lines, material or fissures in solar cells that we will name "spider effect" or "spider" in the following. We can distinguish at least two types of spider:

- 1) *Spider or type 1*: one cross-like that in general has two arms which subtends an angle of around 45° with respect to the main contacts and has a lead-like structure (figure 1-J, 1-L).
- 2) *Spider type 2*: A more complicated spider with a more transparent structure and bubbles (figure 1-

H).

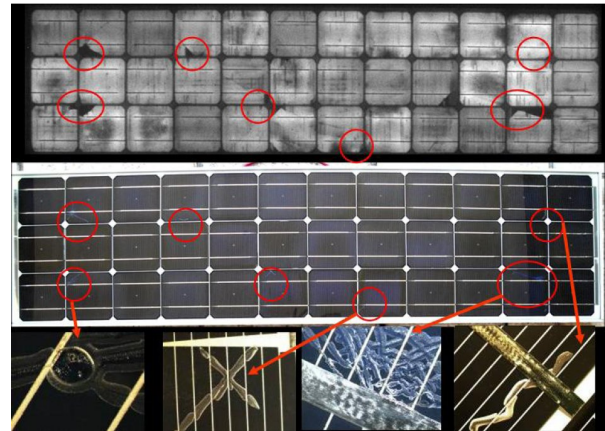
Fig. 2. From up to the bottom: electroluminescence images from, spider panel and this last detailed visual inspection.

- Fig. 2 shows a detailed correspondence between regions with spiders in visual inspection and dark spots in electroluminescence images.
- Spider Type I, shows privileged directions compatibles with the symmetry axis of the silicon crystals. A possible cause is related to failures on the silicon wafes.
- From the big resolution images in visual inspection, we could see how spiders type II seem to be composed of something like different melted fluids and even bubbles of it.

In the figure, the normative (UNE-EN 61215) visual inspection photographs and the electroluminescence ones are shown. Among the possible causes, different hypothesis can be established:

- A problem during the manufacturing processes, in which invisible fissures or inhomogeneities in silicon slides could be translated into a macroscopic effect like spiders.
- The effect of a mixture between hard temperature oscillations and strong winds which can induce fractures in material in time.
- Accumulations of charge (polarisation) in some specific regions of the solar panels caused by some kind of bad connection in system installation.
- Storms or solar storms which very high electromagnetic fields involved could cause such degradation in modules.
- Damages correlated with the extreme

From electroluminescence image and the strange appearance of spiders, the first hypothesis appears is the most probable one since the anomalies in that images are present even in the calibrated solar module and we expect they end up being normal spiders if the panel was installed in the field. More detailed studies including invasive tests are under way.

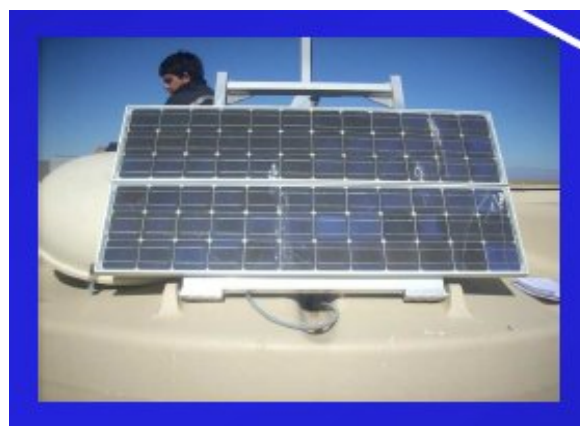
In 2010 May, helped by the Auger technicians, a series of panels that were suspected of having failures have been measured directly on the field. One of the analysed tanks is shown in fig. 3. As it can be seen, the solar module presented blue cells, a slightly brown shade and some spiders. Our visits were focused in two different zones:

Fig.3. Sample of solar modules with several anomalies.

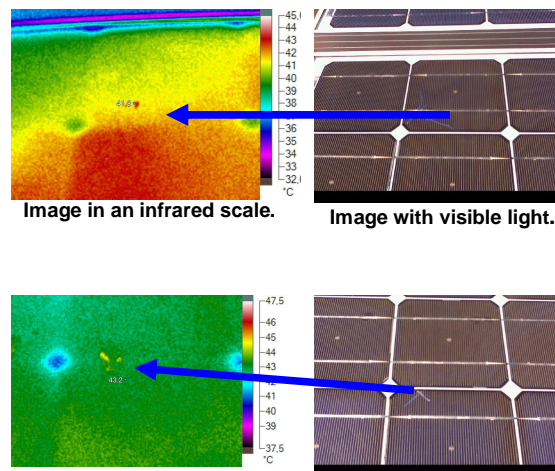
The apparition of a ‘hot spot’ could also explain the effect observed before. To determine a possible correlation between spider and hot-spots, a series of thermographic measurements were carried out in our lab. In fig. 13, photographs both infrared and visible of some representative spiders are presented: In the upper, the higher size spider in the panel, in the bottom one, a typical 2 arms spider.

From the photos, we could state that, although a habitual correlation between spiders and small inhomogeneities concerning temperature of photovoltaic module is present, this effect does not exceed 2-3 extra degrees with respect to its surrounding area; neither is always placed in an accurate way over the structure of the spider itself. The temperature values are obtained over the glass surface and thus they are lower than the real cell-temperature in, at least, 10 degrees, but always, without reaching in any case alarming levels. Concluding, even if the spider’s zone presents a slightly higher temperature, we can not conclude any evident relation between spiders and hot spots.

Fig. 13: infrared (left) and normal photographs of a spider solar module under the direct sun-light.
