# Quality inspection of a 2.85 MW PV power plant under mismatch loss due to different classes of PV module installed

In this paper, the quality inspection of a Photovoltaic (PV) power plant under a mismatch effect due to the use of 18 different classes of PV modules from 5 different manufacturers is presented. The quality inspection has been carried out by three different tests; a visual inspection, an infrared (IR) thermography inspection and electrical monitoring. More than 800 IR thermography images have been analyzed to cover all PV modules installed. Some inverters have been electrically monitored to measure electrical parameters, being the focus of this paper the output energy. A PV plant database has been studied to calculate a mismatch power factor of the PV arrays connected in the measured inverters. Mismatch power factor, hot spots and the output energy of the measured inverters have been compared. Results showed that output energy is influenced by the existence of mismatching. In some cases, compared inverters showed a power loss of up to 10%.

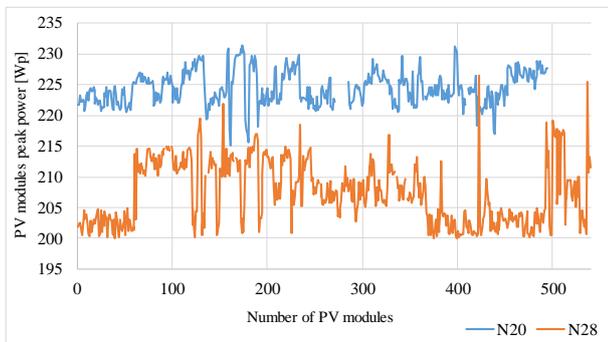
In fig. 2, it has been represented PV modules MPP of inverters N20 and N28 according to flash report database. PV modules installed in N20 had higher MPP values than in N28. However, in N28 there were more PV modules connected. In N28 can be observed the variability of the dates due to the use of different PV modules classes, so mismatch power rate was higher in N28 than in N20.

Fig. 2. Comparison of data on mismatching in N20 and N28

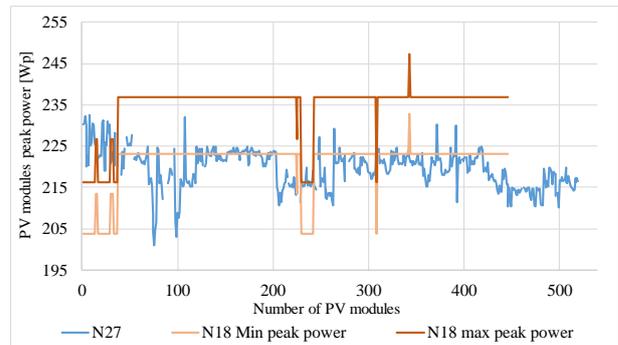
So, in Fig 3, HVMP and LVMP of PV modules in N18 has been compared with PV modules MPP of inverters N27 according to the flash report database. In N27 there were more PV modules connected than in N18. As both inverters had the same number of different classes of PV modules connected, the variability of dates in N27 and N18 were similar. However, the MPF is higher in N18 than in N20.

Fig. 3. Comparison of data on mismatching in N27 and N18

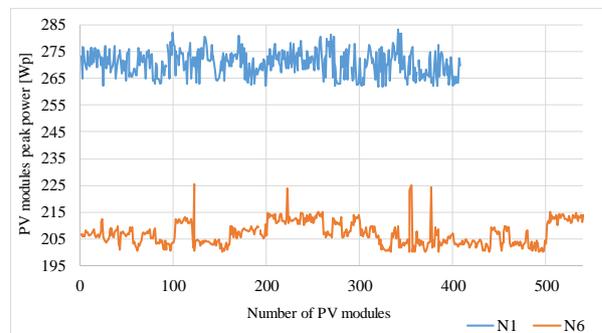
In fig. 4, it has been represented PV modules MPP of inverters N1 and N6 according to the flash report database. PV modules installed in N1 had higher MPP values than in N6. However, in N6 there were more PV modules connected. In N6 can be observed the variability of the dates due to the use of different PV modules classes, so MPF was higher in N6 than in N1.

Fig. 4. Comparison of data on mismatching in N1 and N6

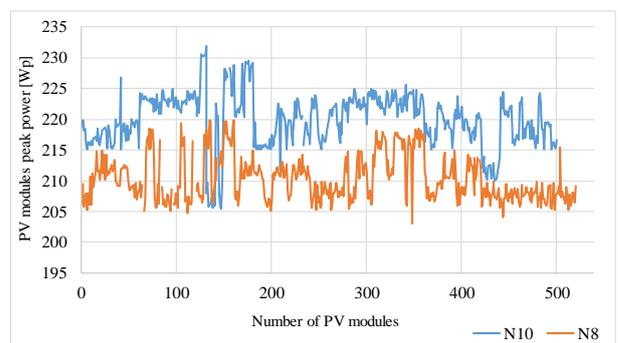
In fig. 5, it has been represented PV modules MPP of inverters N10 and N8 according to the flash report database. PV modules installed in N10 had higher MPP values than in N8. However, in N8 there were more PV modules connected. In N10 can be observed the variability of the dates due to the use of different PV modules classes, so mismatch MPF was higher in N10 than in N8.

Fig. 5. Comparison of data on mismatching in N10 and N8

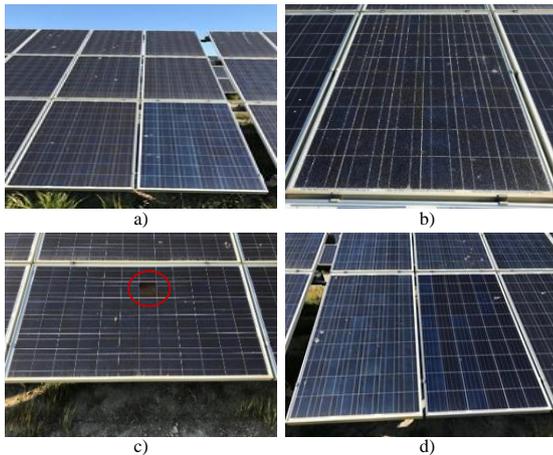
Once the visual inspection of the PV plant has been carried out, several defects have been found. Defects found in the PV plant has been: anti-reflective layer discoloration, browning, yellowing, burned PV cells, snail tracks, milky front-glass, broken front-glass, and the connection of different PV modules classes coming from several

manufacturers in the same string. Figure 6 shows some defects found. It is worth to highlight the lack of cleaning under the evidence of soiling and bird dropping.

Fig. 6. Some defects found in the visual inspection. a) discoloration, b) broken front-glass, c) burned PV cell, d) connection of different PV modules

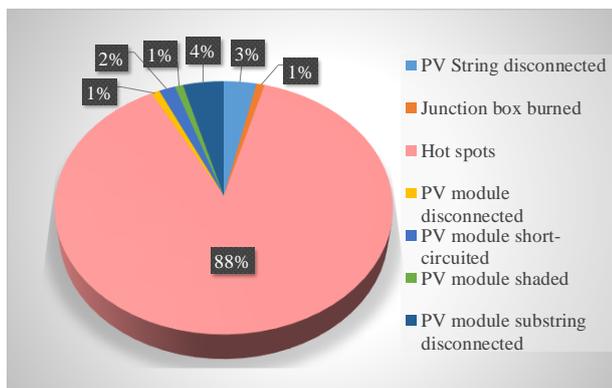
More than 800 IR images have been analyzed and a total of 117 IR images shown thermal anomalies in PV modules. Fig.7 shows different thermal anomalies found through the 117 images. 103 IR images, 88% of the total, have been caused by hot spots, which mean less than 1% (0.76%) of the whole PV power plant. Some PV modules defects found in the IR thermography inspections have been also found in the visual inspection. Fig. 8 shows a PV module with 2 burned PV cells with its thermal response detected at the rear of the PV module in the IR thermographic inspection. The temperature reached in the hot spot was 91.6 °C.

Fig. 7. Defects found in the IR thermal inspection

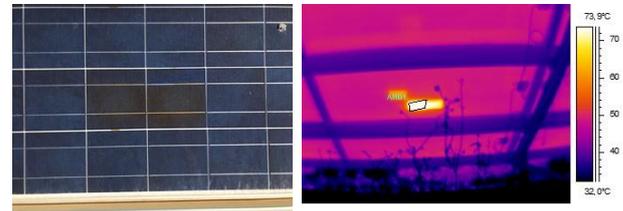
In some cases, unlike it is shown in Fig. 8, the IR thermal inspection detected hot spots that were not detectable in the visual inspection. A considerable problem is caused by the fact that PV modules affected by hot spots not only have a reduction of its own efficiency but also it could cause a reduction of the generation capacity of the whole string where it is connected [5].

Fig 8. PV module with burned PV cell.

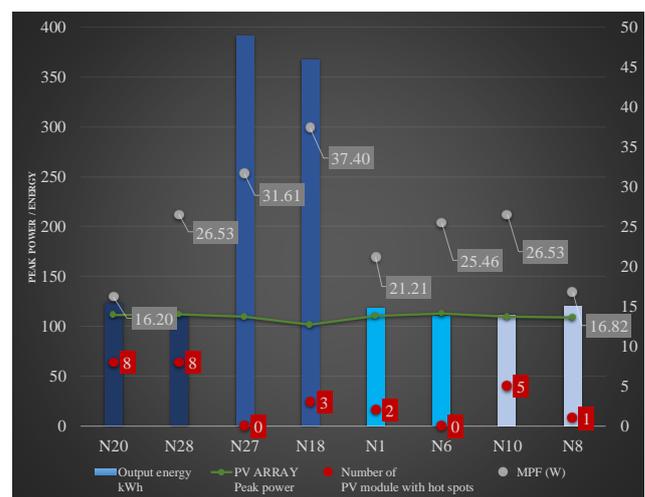
Fig. 9. Peak power, mismatch, hot spot and energy relationship in the compared inverters.

Compared inverters N20-N28, N27-N18, N1-N6 and N10-N8 have almost produced the same energy, which indicates its homogeneous operation. However, there were some differences in output energy. Inverters with higher values of mismatching rate injected less energy. N28, which had a mismatching rate difference of 10.33 W, produced 13.17 kWh (10.67%) less than N20. N18, which had a mismatching rate difference of 5.79 W, produced 23.07

kWh (5.91%) less than N27. N6, which had a mismatching rate difference of 4.26 W, produced 9.18 kWh (7.72%) less than N1. N10, which had a mismatching rate difference of 9.71 W, produced 9.04 kWh (7.50%) less than N8. However, there was no relationship between the values of MPF and the number of hot spots detected. As it is shown in N6, where has been obtained an MPF of 25.46W and any hot spot was detected.
