PV power stations – fire hotbeds and fire tolls

Abstract. This article deals with photovoltaic power stations acting as possible fire hotbeds and simultaneously fire tolls. Main PV features defining fire risks of alone standing or on building mounted power station are discussed. Analyses described in main chapter are based on real case of a lightning strike. Divergence between direct lightning strike and close lightning strike is deeply illustrated and possible protections are discussed. Following paragraphs deal with fire rating and fire performance of particular PV panels, relevant dangers for acting firemen, extinguishing ways, particular fire progress and secondary hazards. The problematic is demonstrated on the base of experimental photovoltaic plant fire and real examples of injured panels.

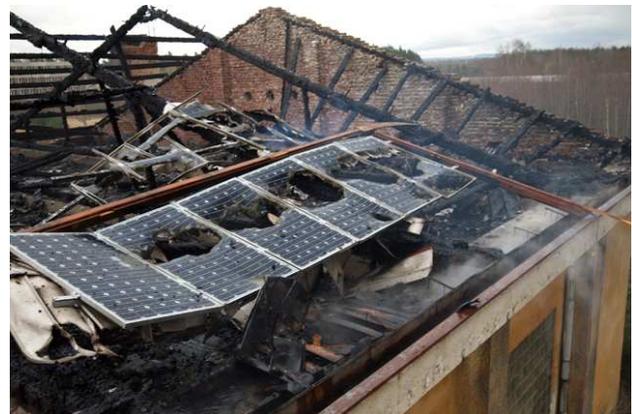
Events with natural background or specific human activities can, from our point of view, abstractedly on the motive lead in the consequence to the fire. PV power stations installed on buildings are more endangered than stand alone installations. The fire can be initiated inside the building independently of the plant components. Faulty electrical installations, defective house appliances or some misfortune events are good examples. On the other hand PV plant components can itself initiate the fire. Electrical component malfunctions or unpredictable result of natural events are typical events. Fig. 1 shows roof mounted PV power plant after fire of the building.

Fig. 1. Roof mounted PV power plant after fire.

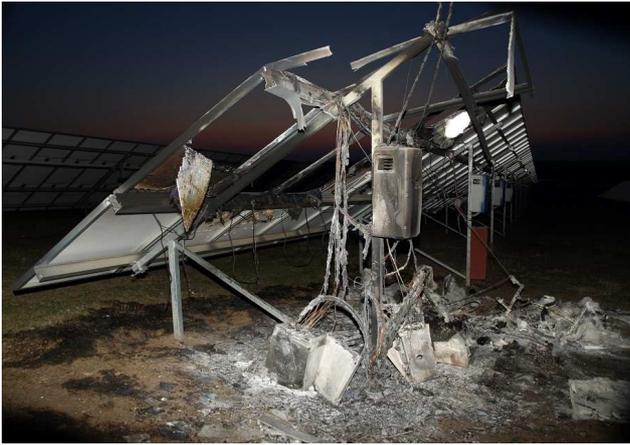
Large stand alone PV power plants are paradoxically smaller problem from the fire point of view. These systems are usually installed on a free area. No surrounding objects are to be affected or to affect the plant as demonstrated on Fig. 2 [3].

Fig. 2. Stand alone PV power plant after fire.

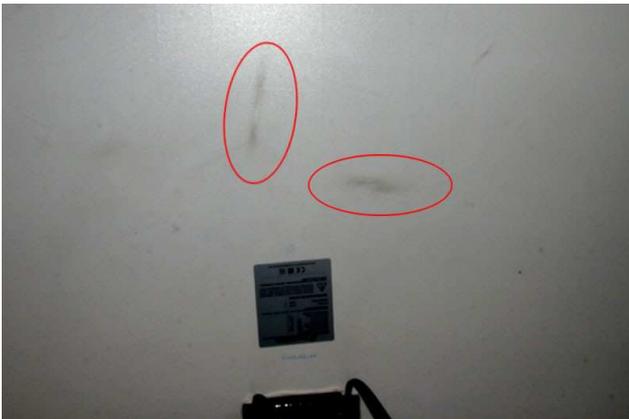
The other situation is much more frequent. Consequences are more difficult to identify, because the damage itself is caused only by some overvoltage. Although the semiconductor structures show serious malfunctions, the panel and surrounding objects are visually not affected or the particular degradation is almost not evident. Fig. 3 shows smoke traces on the backside of a panel damaged during lightning strike into close chestnut tree [3].

Fig. 3. PV panel damage after close lightning strike.

Subsequently a lightning hit into chestnut tree standing 15 m far from the industrial hall was located. Few superior branches were broken off and the trunk showed burn traces from the lightning downlead. Because the trunk had not been split, the lightning was classified as rather small. Close distance between the tree and the industrial hall caused that overvoltage had been induced between the supporting structure and wiring of the photovoltaic power plant [3].

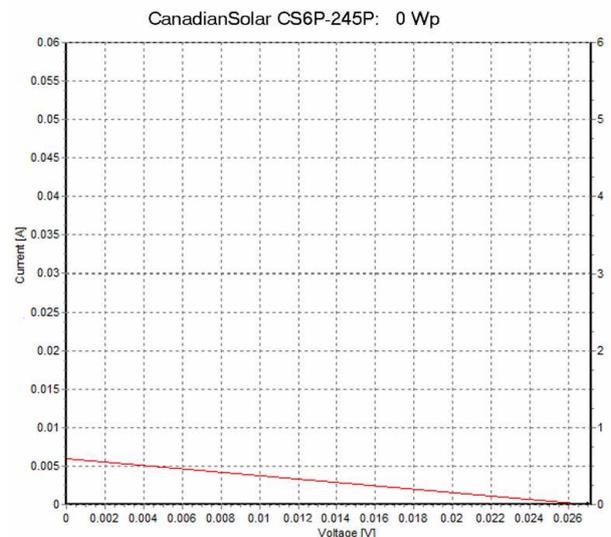
No usable VA-characteristic was recorded. Example measured in conditions very close to STC ($I_p = 983$ W/m², $t_p = 26.8$ °C) is demonstrated on Fig. 4.

Fig. 4. VA-characteristic of tested panel.

The nominal output voltage of the tested panel at STC is $U_{MAX} = 35.6$ V and nominal current is $I_{MAX} = 6.7$ A. The output voltage dropped almost to 0 V while the output current almost did not ascend above 0 A once the load was connected to the panel during the measurements. The panel was disconnected and shaded to cool down before this measurement to get as close to STC as possible for the particular experiment.

As evident from Fig. 4 maximum power point (MPP) was also not measured. The only sign of partial functionality is some low value of open circuit voltage recorded during additional measurements and presented in Table 1.

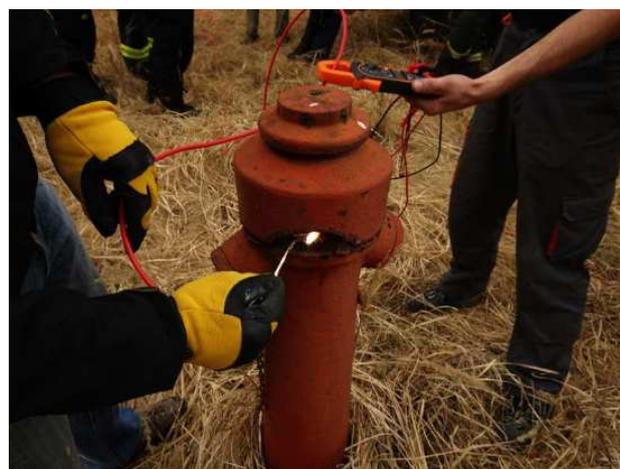
Fig. 9 presents sample measurement of secondary hazards – DC sparks. One of the output wires from PV string was grounded while the second one was freely and randomly used to ignite sparks on surrounding objects.

This situation often happens, when power wires are broken (burned or cut) and loosely hanging in the space. Any contact between the wires among each other can ignite a spark. Also random touch of one wire with some metal object (water drips, pipes, girders, sheetmetals, etc.) while the second wire is in synchronous contact with that object can initiate shortcut current and/or sparks.

Fig. 9. Sample of secondary hazards – DC sparks.

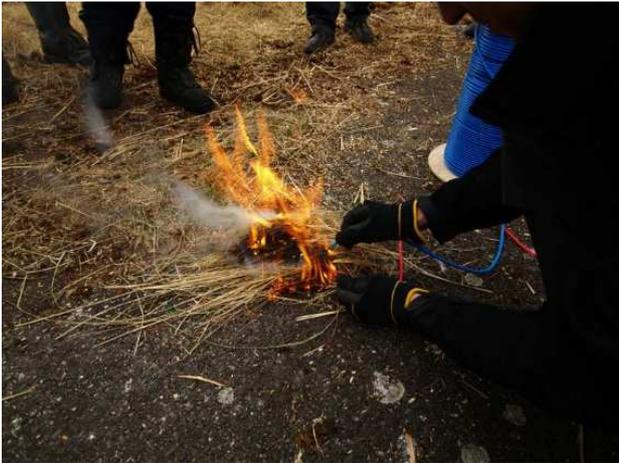
Although the ambient conditions were not ideal, experiments proved that these sparks have enough energy to initiate a fire of several typical flammable materials as shown on Fig. 10.

Fig. 10. Energy of sample DC sparks.

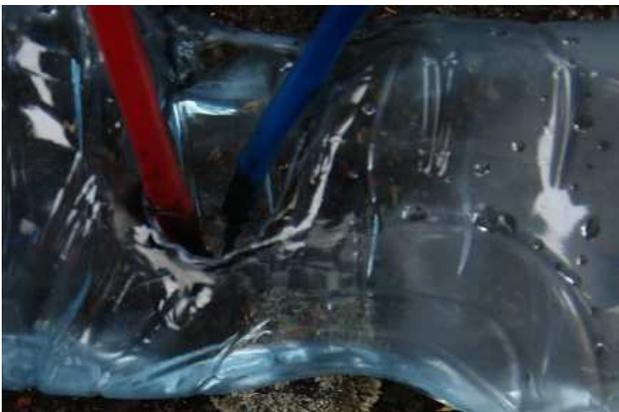
DC currents represent also another type of hazard that must be on mind while using water beam for extinguishing. Water electrolysis occurs in wet ambient, what means H_2 and O_2 production. Any higher H_2 concentration brings high explosion risk especially in environment with common initiating electric sparks. Fig. 11 demonstrates generation and caption of H_2 in some enclosed space (plastic bottle).

Fig. 10. H_2 generation in enclosed space.

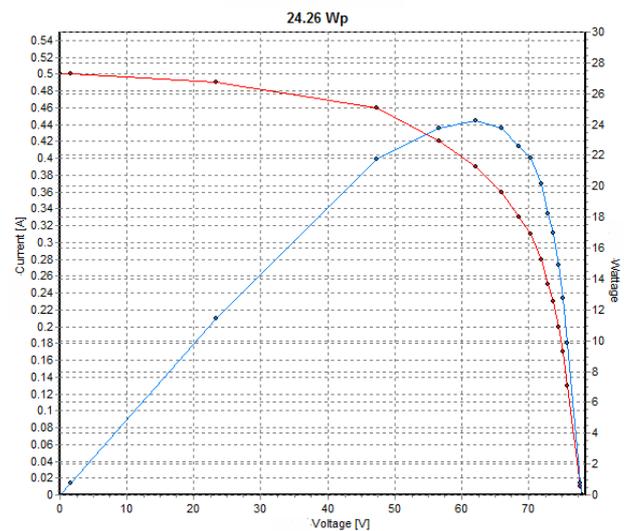
Measured VA and power characteristics of string 1 during the fire are presented on Fig. 11, Fig. 12 and Fig. 13. The partial power decrease on Fig. 12 can be explained with smoke shading the panels, while Fig. 13 shows zero output of damaged string.

Fig. 12. Sample VA characteristic (time 6:35 min)

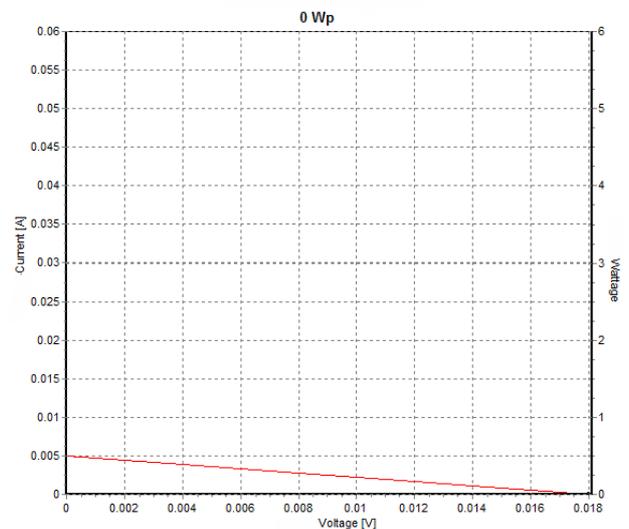
Fig. 13. Sample VA characteristic (time 10:12 min)

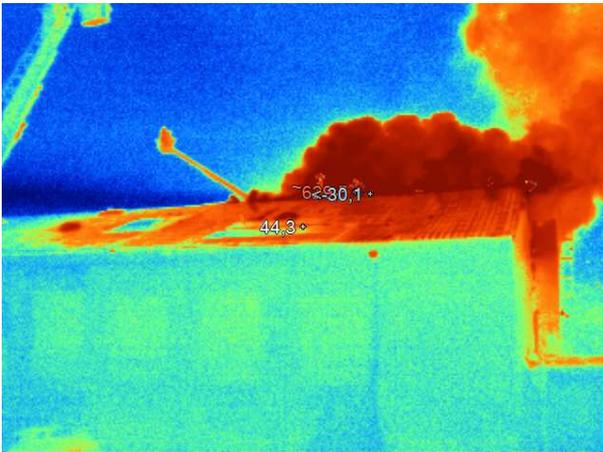
Sample thermogram from the fire progress (4:45 min) is demonstrated on Fig. 14. Panels on metal roof (middle of the picture) and panels on tiles (left part of the picture) are not affected yet, while panels on the tar roof are in the flames (upper right part of the picture).

Fig. 14. Sample thermogram (time 4:45 min).

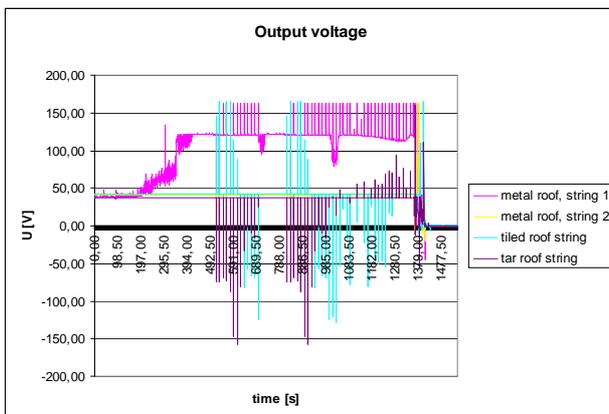
Fig. 15 shows the output voltage of all strings. It is evident that voltage fluctuated and even exceeded the nominal value. This unpredicted behaviour has simple explanation. Burned wires composed random temporary connections leading to overvoltage and even reverse voltage on the string output.

Fig. 15. Output voltage during the fire.
