Thin-film PV modules early degradation analysis: a case study on CIGS

A.M. Diez-Suárez¹, D. de la Calzada-Lorenzo¹, A. González-Martínez¹, L. Álvarez-de Prado², Á. de la Puente-Gil¹, J.J. Blanes-Peiró¹ and M. de Simón-Martín¹.

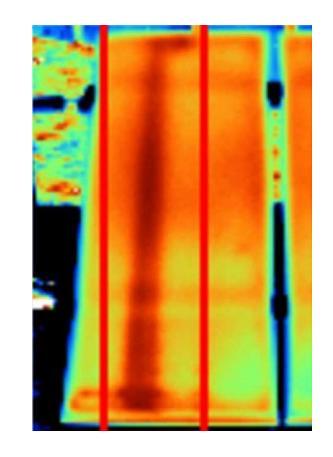
In the visual inspection, only one defect was detected in the CIGS thin-film PV modules (module ID: 03), as it can be seen in Fig. 6. It is a hot spot spread as a whole stripe from the bottom to the top parts of the PV module, which is called hot spot stripe. This sort of fault have been previously reported in other works which detected it in laboratory tests by using electroluminescence and lock-in thermography techniques [15].

Fig. 6. Thermographic picture of the found hot spot stripe on CIGS thin-film module ID 03.

Finally, Table I summarizes the main electrical parameters evolution on the five tested CIGS thin-film PV modules. The failure detected in module ID03 is a hot spot stripe. Although, hot spots in thin-film PV modules are usually caused by partial shading conditions, this is not the case as no shadows are projected on the PV modules. On the other hand, a manufacturing origin is also discarded, as it was not registered before installation. Therefore, it could be possible an spontaneous origin reason, as other authors have reported -hot spots with significant temperature increase (\sim 300 K) can spontaneously emerge in laterally uniform thin film photovoltaics- [16]. However, as shown in Table I, the hot spot stripe seems not to have a significant impact on the module's performance.

The 3.3% reduction of the peak power on the hot spot stripe affected module can be caused by the substantial increase of the cell temperature that the failure has provoked. Further studies must be conducted in this way.

Furthermore, one hot spot stripe has been detected in a PV module working outdoors only for 3 years, which origin seems to be spontaneous. Although most electric parameters seem to be in the normal range in this module, a significant 3.3% peak power dismiss has been observed.
