# Deterioration and performance evaluation of photovoltaic modules in a semi-arid climate

**Abstract.** PV modules are the most reliable component of a photovoltaic (PV) system. This supposed reliability leads the modules to have a warranty of up to 25 years. With the increasing insertion of PV in the energetic matrix, it is necessary to evaluate and guarantee the reliability of this source. This paper presents an evaluation of degradation in PV modules installed 15 years ago on the roof of the Department of Electrical Engineering, Federal University of Ceará, Brazil. This evaluation uses two methods: visual inspection and analysis to measure degradation degree in electrical properties of the modules. Maximum power ( $P_{MPP}$ ); Current at the maximum power point ( $I_{MPP}$ ); Voltage at the maximum power point ( $V_{MPP}$ ); Short circuit current ( $I_{SC}$ ) and Open circuit voltage ( $V_{OC}$ ) are measured using a power curve tracer and compared with manufacturers data. Visual analysis show that delamination and discoloration are the degradations found in most of the modules. Considering the electrical parameters, a MPP reduction of 30% was found.

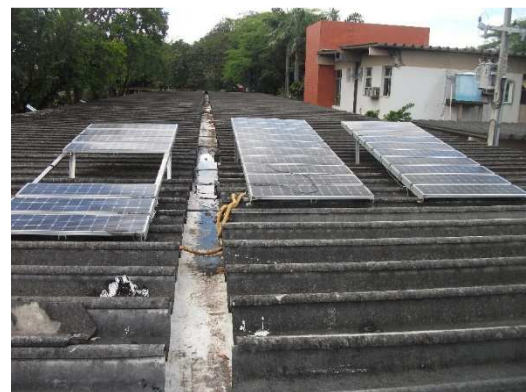
Fig. 1. Layout of the PV modules under investigation.

The two rows of the right side (Fig. 1) are composed of 10 modules connected in parallel at each five modules. The left row shows seven modules connected individually. In this study, visual analysis was made in all modules and analysis of the electrical parameters focused on the row with seven modules. Each of these modules consists of 36 monocrystalline silicon cells with 1293 mm in length, a width of 392 mm and 34 mm thick. The module electrical characteristics are given in Table I.

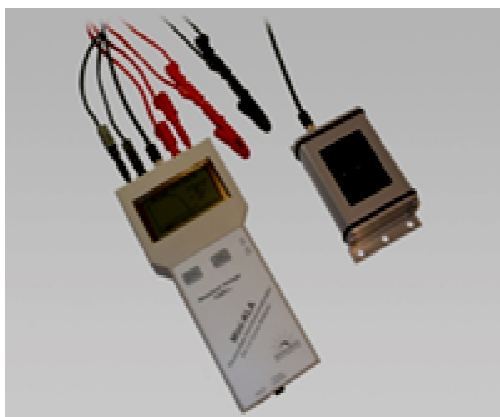
Fig. 2. Mini-KLA analyser.

This analyser is a complete measurement system to trace IV-curves of PV modules with open circuit voltages up to 120 V and short circuit currents up to 8 A. The global irradiance ( $W/m^2$ ) and the module temperature were measured simultaneously with a reference cell attached to the analyser, so that all relevant parameters for calculating data STC (Standard Test Conditions) were considered.

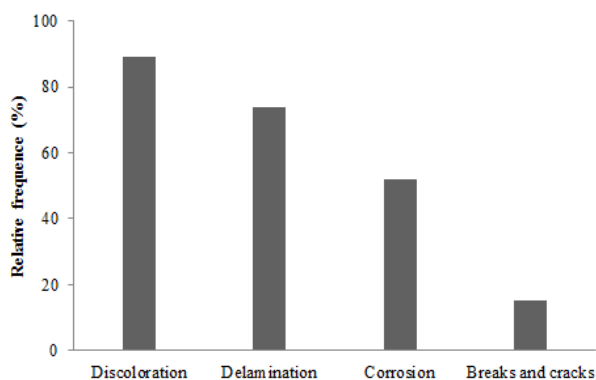
The main forms of degradation found in the 27 PV modules under investigation and the frequency of occurrence of these degradations are shown in Fig. 4.

Fig.4. Frequency of degradations (discoloration, delamination, corrosion, breaks and cracks) found in the PV modules.

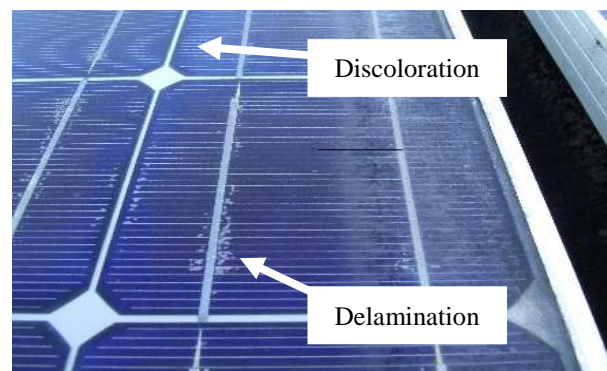
Discoloration was found in practically all cells, although at different rates. The delamination process occurs in 20 of the 27 modules, with different intensities. In most of the cases, the effect of delamination was found linked with discoloration, according to Fig.5.

Fig.5. PV module showing discoloration and delamination.

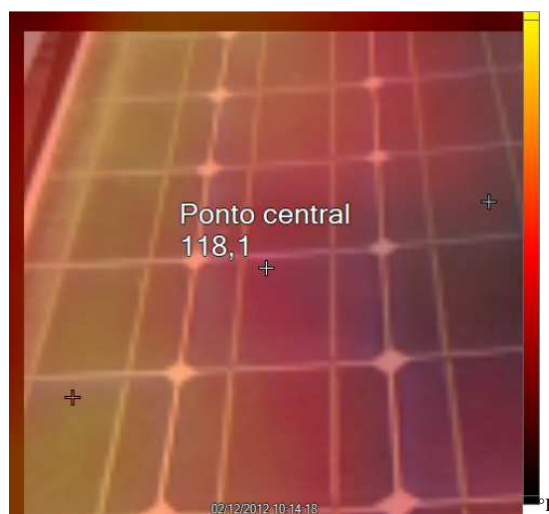
These forms of degradation are a consequence of the presence of hot spots, according to Fig. 6, showing different temperatures.

Fig. 6. Hot spots in a PV module.

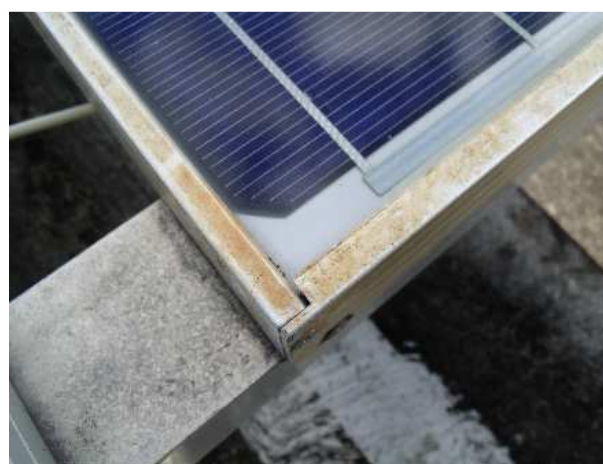
Corrosion was found in almost 50% of the investigated modules. From 27 modules, three had a more intense corrosion process (Fig. 7).

Fig.7. Corrosion of structural elements in a PV module.

The structural elements of all arrays, like details made of corrosive materials, showed advanced corrosion, with thick layers of oxidized material. Breaks and cracks were observed in only two modules.

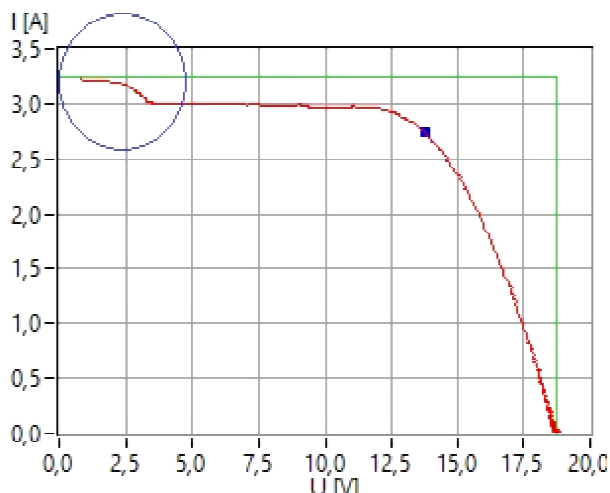
All seven modules under investigation showed an anomaly in the IV-curve near the short circuit point, as can be seen in Fig. 8. To confirm this anomaly, tests were performed with other PV modules, both monocrystalline and polycrystalline, and showed no deformation in the region, thus ruling out the possibility of having been an anomaly arising from the equipment as well as measurement errors and confirmed so that all seven modules have degradation in the IV-curve.

Fig.8- IV-curve anomaly found in the module 7 (M7).

This failure in this curv may be related to the presence of hot spots on the surface of the module. The high temperatures at hot spots reduces the cell voltage and thus reduce the performance of the photovoltaic cell and eventually hamper the performance of the module [9].
