Efficiency of auxiliary mounted passive solar systems

Abstract. This article discusses the efficiency of passive solar systems auxiliary mounted on existing buildings. The first paragraph deals with measurement methods applicable for passive systems. Following text describes the elimination and correction of result uncertainties. The main part focuses on measurement and evaluation of several practical solar passive systems applications. The optimal process mode is explained as the main result of this research.

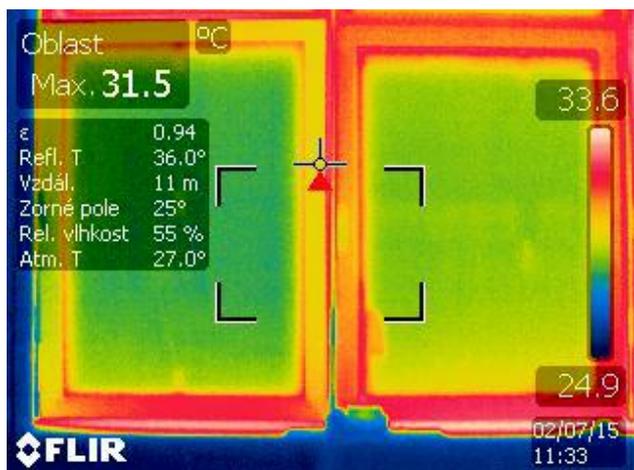
Firstly, infrared cameras Flir T335 and Fluke TiX640 were used to display temperature lay outs. Extensive emissivity range of used structural materials involved proper and accurate interpretation of recorded thermograms. The emissivity depends not just on the material itself, but also on surface trimming and color. This heterogeneity cannot be in this case eliminated sufficiently. So these results can be used only for proximate visualization as shown on Fig. 1.

Fig .1. Sample thermogram. (Flir T335).

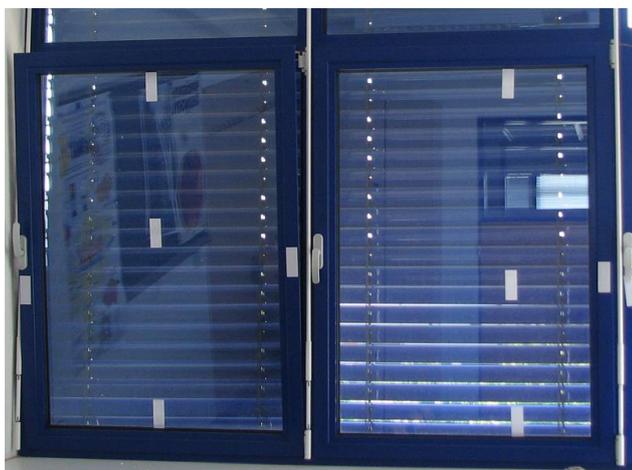
Non-contact thermometer Raytek Raynger ST was than used for more accurate measurements. Diverse emissivity of component materials was matched through thin dull

paper adhesive foil. Measuring points were situated in the center of this modified surface.

3 measuring points were marked on glass surface (bottom, middle, top) and 1 on the frame of each window. This scheme enables (1) to compute not just the total heat penetration through the window (coefficient C_w , area $A_F + A_G$), but also partial ingredients of the glass area (coefficient C_G , area A_G) and the frame (coefficient C_F , area A_F). Example of the measuring points is displayed on Fig. 2.

Fig. 2. Measuring points with correction tape.

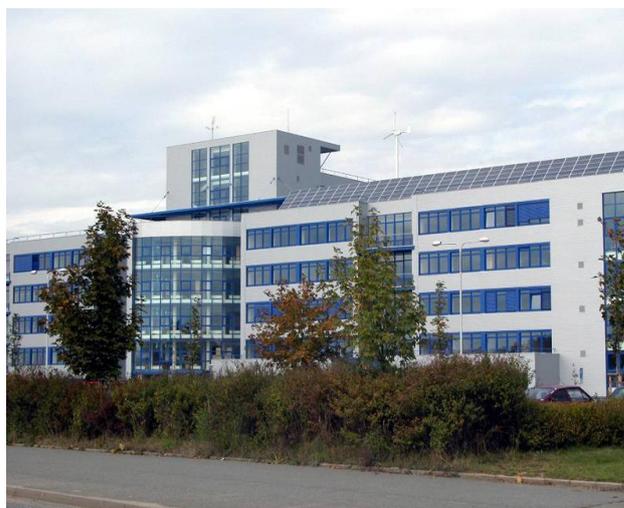
New building of Faculty of electrical engineering stands as the Example 1. Standalone concrete building was finished in 2004 and the most significant features are large windows and design metal encasement. The object has 8 floors, no basement and flat roof without any loft. Foreside of the building is south facing. Partial balcony miradors generate limited shades, but are not able to avoid overheating of the building during summer months. Absence of any surrounding shading object and large tarmac paved car park progress the situation. Overview and disposition is displayed on Fig. 3.

Fig. 3. Example 1 (Faculty of electrical engineering, Pilsen).

All windows and doors are metal framed with blue painted surface ($C_F = 2,2 \text{ W/m}^2\text{K}$). Architectonical and aesthetical reasons enforced this energy non efficient solution. Panelboards consist from standard two layer insulating glass ($C_G = 1,4 \text{ W/m}^2\text{K}$). All windows are equipped with internal silver coloured metal sunblinds.

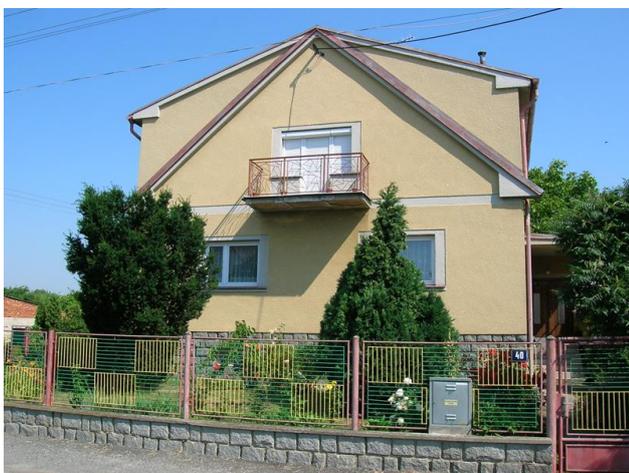
Standard small family house in Dolni Porici stands as the Example 2 presented on Fig. 4. Standalone brick building was finished in 1972. This two story building has full size basement and loft. Outbuilding on the second floor was finished during 1976 from breeze blocks, tiles and hollow bricks. Front side of the building is south facing. Small terrace and roof overlaps generate limited shades, but are not able to avoid the building overheating during summer months. No other shading objects are in the surrounding area. Old casement windows were replaced with new plastic windows ($C_F = 1,3 \text{ W/m}^2\text{K}$) with standard two layer insulating glass ($C_G = 1,4 \text{ W/m}^2\text{K}$).

Fig. 4. Example 2 (Family house, Dolni Porici).

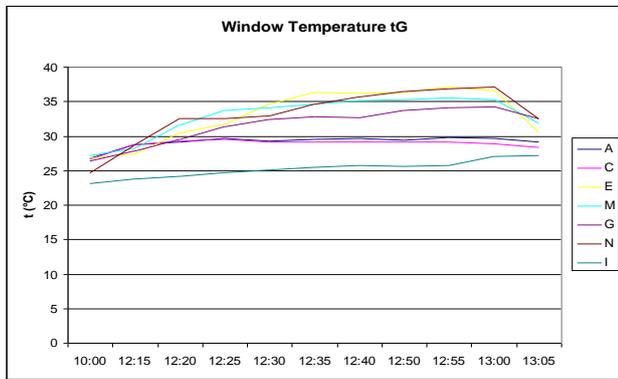
Table II shows supreme values measured on all systems, while Fig. 5. presents history of temperatures in selected cases (A, C, E, M, G, N, I) during direct insolation. T_G indicates maximum temperature on the glass, T_{IN} means average interior temperature and T_w shows surface temperature on simulated working area.

Fig. 5. Window Temperature on insulated side (10:00 – 13:05).

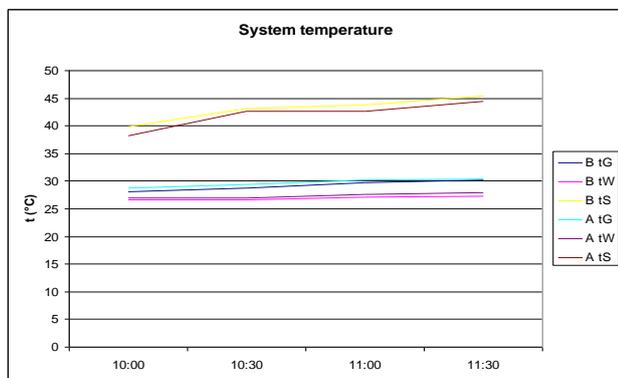
Fig. 6. shows the temperatures of equivalent systems (A, B) during direct insolation and effect of the systems on internal climate (t_G indicates window temperature, t_w indicates surface temperature on working area and t_s means surface temperature of selected system). The chart clearly identifies the influence of slots on higher internal temperatures while the system itself is cooler.

Fig. 6. System Temperature on insulated side (10:00 – 13:05).
