Assessment of the Performance and Defect Investigation of PV Modules after Accelerated Ageing Tests

J.A. Tsanakas¹, M. Karoglou², E.T. Delegou², P.N. Botsaris¹, A. Bakolas², A. Moropoulou²

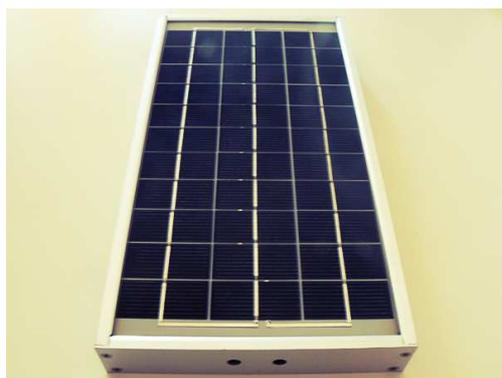
Fig. 1. The *PV-1* module.

The testing objects of this study were three mc-Si PV modules, named as *PV-1*, *PV-2* and *PV-3*. *PV-1* consists of 33 mc-Si solar cells (Figure 1) and according to its specifications (at standard test conditions, STC), features a P_{max} of 6 W_p (for which it is $I_{mpp}=0.39$ A and $V_{mpp}=15$ V), short-circuit current $I_{SC}=0.42$ A and open-circuit voltage $V_{OC}=19.5$ V. *PV-2* and *PV-3* consist of 36 mc-Si solar cells (Figure 2) and feature (at STC) a $P_{max}=5$ W_p (for which it is $I_{mpp}=0.285$ A and $V_{mpp}=17.82$), $I_{SC}=0.315$ A and $V_{OC}=21.96$ V.

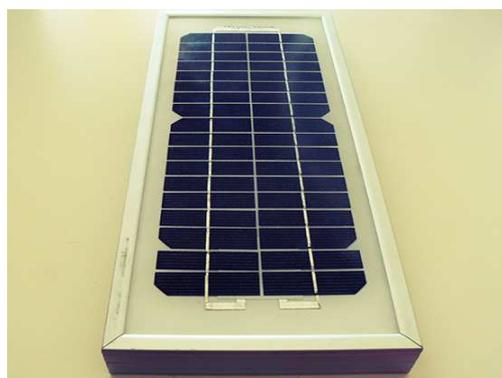
Fig. 2. The *PV-2* (and *PV-3*) module.

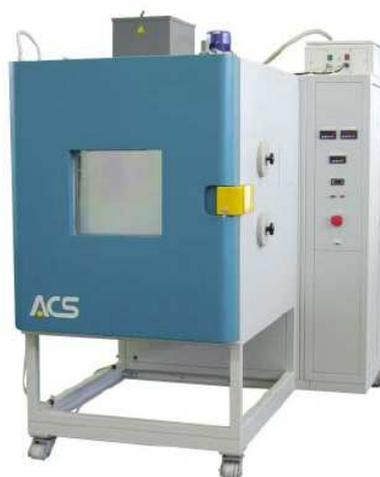
Fig. 3. The *Angelatoni GTS600* test chamber.

The thermal cycling test was performed at an *Angelatoni Industrie GTS600* accelerating ageing test chamber (Figure 3), including a total number of 106 thermal cycles (Figure 4), from -15 °C, to +70 °C, with ambient (starting) temperature of 25 °C, and a temperature change ratio of 0.8 °C/min., resulting to a total duration of about 4.5 hrs per cycle.

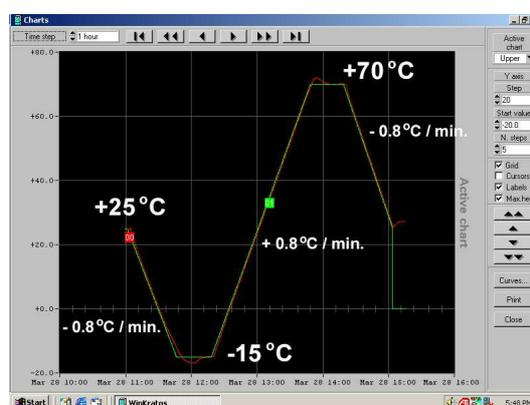
Fig. 4. The thermal cycling scenario of the study.

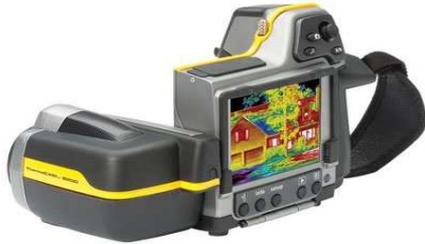
Fig. 6. The *FLIR B200* portable thermal imager.

IR measurements were performed by two portable thermal imagers; an *Impac IVN780-P* (Figure 5) and a *FLIR B200* (Figure 6). *IVN 780-P* features a 320×240 uncooled focal plane array (UFPA) microbolometer detector with a spectral range of 8 to 14 μm, temperature range of -40 to +1000 °C with temperature resolution of 0.1 °C, image resolution of 320×240 pixels and instantaneous field of view (IFOV) of 1.5 mrad. On the other hand, *FLIR B200* features a 200×150 UFPA microbolometer detector with a spectral range of 7.5 to 13 μm, temperature range of -20 to +120 °C with temperature resolution of 0.08 °C, image resolution of 200×150 pixels and IFOV of 2.18 mrad. All I-V measurements were performed with the use of a *Range RE69 41/2 DMM* conventional multimeter, providing the magnitudes of I_{SC} (short-circuit current) and V_{OC} (open-circuit voltage). The specific model has a 0.1% basic accuracy with a 2 mA - 10 A DC current range and a 200 mV - 1000 V DC voltage range. The modules were short-circuited and open-circuited in the field, under illumination (clear-sky conditions), with a fixed inclination of 30°. Last but not least, the optical measurements were performed by an *i-Scope Moritex* fiber optic microscope (FOM) and a specialized photographic lens *Nikkor AF Micro 60* mm.

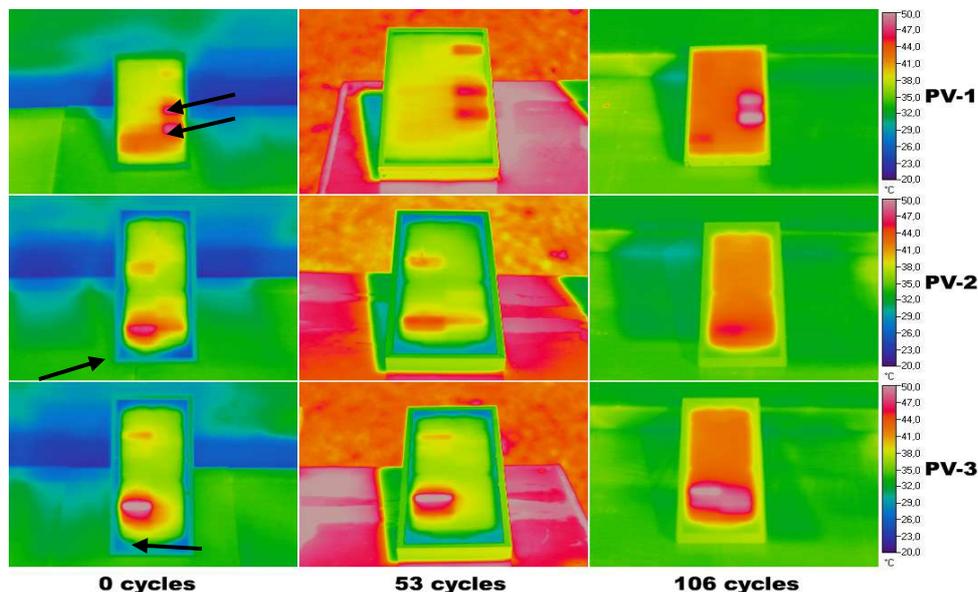
Fig. 7. The resultant thermal images for *PV-1*, *PV-2*, *PV-3*, during the IR measurements of 0, 53 and 106 thermal cycles.

Figure 7 presents the resultant thermal images from the IR measurements of *IVN780-P*, that show the evolution of *PV-1*, *PV-2* and *PV-3* thermal signatures over the effect of different ageing process stages: 0 thermal cycles (initial state) 53 thermal cycles (half-aged) and 106 thermal cycles (fully-aged). Similar results were obtained by the *B200* thermal imager. In order to achieve significant thermal response and variations over any possible defect, all modules underwent IR measurements after 15 to 30 minutes of field exposure, under short-circuit conditions. The acquired thermal images from the inspected PV modules were analyzed in order to generate a simple and fast correlation between the expected cell temperatures ($T_{c,exp}$) of each module and the measured cell temperatures ($T_{c,m}$), obtained from these field thermographic inspections. In practice, a $\Delta T > 5^\circ\text{C}$ between $T_{c,exp}$ and $T_{c,m}$ witnesses a potential defect (hot spot) [1]. According to Skoplaki et al. [18], the expected operating cell temperature, can be fairly estimated by the following semi-empirical equation:

Beginning with the thermal image analysis of *PV-1*, the attention is focused on two “suspicious” cells (as indicated by the black arrows in Figure 7), which were measured with an average cell temperature $T_{c,m}=47.5^{\circ}\text{C}$. At the same time, an apparently “healthy” cell in *PV-1*, presents a $T_{c,m}=38^{\circ}\text{C}$. Applying eq. (1), for the environmental parameters of this measurement (0 thermal cycles), given in Table I, the expected cell temperature is estimated to $T_{c,exp}=38.7^{\circ}\text{C}$. Thus, the “healthy” cells, here, are operating to a temperature very close (by 1.8%) to the theoretical $T_{c,exp}$, in contrast to two cells, diagnosed as defective, as they present an abnormal operating temperature, higher than the normal one by a $\Delta T=8.8^{\circ}\text{C}$. Similarly, a significant ΔT was observed to the operating temperatures of the defective cells, after both 53 and 106 thermal cycles, without – however – any significant change to their thermal signature. In particular, after 53 thermal cycles, a $T_{c,m}=38.7^{\circ}\text{C}$ was measured for the normally operating cells, almost equal to the theoretically estimated (for this measurement conditions) $T_{c,exp}=38.5^{\circ}\text{C}$, while the two defective cells presented an abnormally high operating temperature of $T_{c,m}=45.6^{\circ}\text{C}$, corresponding to a $\Delta T=7.1^{\circ}\text{C}$, indicative of certain fault. Moreover, after 106 thermal cycles, with a theoretically estimated $T_{c,exp}=42.9^{\circ}\text{C}$, a small declination of 2.3% and a $\Delta T=6.1^{\circ}\text{C}$ were measured for the operating temperature of the “healthy” ($T_{c,m}=41.9^{\circ}\text{C}$) and the defective ($T_{c,m}=49^{\circ}\text{C}$) cells of *PV-1*, respectively.

Continuing, in the same way, with the analysis of the thermal images of *PV-2*, at the initial state of the module (before ageing, 0 thermal cycles), the attention was focused on the presence of a “suspicious” area, indicated by the black arrow in Figure 7, which was related to a $\Delta T=7.4^{\circ}\text{C}$ between the expected and the measured operating temperature. For the same area, after 53 and 106 thermal cycles, it was measured, within the thermal images, a $\Delta T=5.3^{\circ}\text{C}$ and a $\Delta T=3.7^{\circ}\text{C}$, respectively, which do not correspond to a clear indication of defect. Although the specific abnormality in the temperature profile of this area is probably related to the presence of the junction box – at the backside cover of the module – further investigation has been made during the analysis of the I-V measurements (see next subsection).

Finally, in the thermal image analysis of *PV-3* module, a “suspicious” cell, with an abnormal temperature profile, has been detected at the initial state, as (similarly to the previous ones) indicated in Figure 7. For the specific cell and for the three stages of ageing (0, 53 and 106 thermal cycles) the related thermal images revealed a significant ΔT of 21.1°C , 15.5°C and 8.9°C , respectively. Moreover, in contrast to the defective cases of *PV-1* and *PV-2*, here the defect appears to change and propagate to the adjacent cells after the conclusion of the 106 thermal cycles, resulting to a defective area of a larger extent, compared to the initial state. In particular, while the defective area of *PV-3*, at the initial state, includes one cell, the effect of thermal cycle ageing has apparently led to an extension of this area to a total number of four cells and, subsequently, to further power degradation, as it will be shown in the next subsection.

It should be clarified that the noticed decrease of the ΔT value, during the ageing process, in all three cases of PV modules, does not imply any restriction of the defects’ severity and their impact to the modules’ power degradation. It can, though, be explained as a result of the expansion of the dissipated heat to the defective areas and its allocation to each whole module.

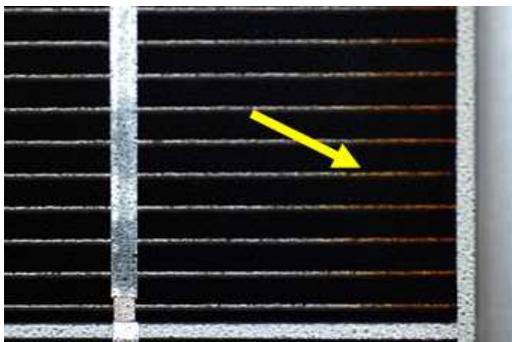
Fig. 8. Optical microscopy image of defective cell in *PV-1*, after the ageing process (106 thermal cycles), showing brown EVA discolorations.

Figures 8-10 present the resultant optical microscopy images of defective cells in *PV-1* and *PV-3*, as diagnosed by the IR measurements, after the completion of the ageing process (106 thermal cycles). As Figure 8 suggestively shows, the specific defective cell in *PV-1* presents partial discoloration (indicated by the yellow arrow), which is characteristic of a degraded ethylene vinyl acetate (EVA) encapsulant film. Similar parts of defective cells were noticed in Figure 9, due to either electrical mismatches (distorted busbars, 1st arrow) degraded EVA film (brown discolorations, 2nd arrow) or possibly degraded anti-reflection coating of the cells (cyan discolorations, 3rd arrow). With regard to Figure 10, the defective parts of *PV-3* were found with specific cyan discolorations, possibly related to degraded anti-reflection coating, as in the 3rd case of Figure 9.

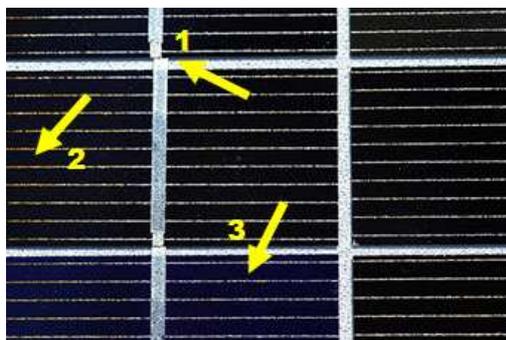
Fig. 9. Optical microscopy image of defective cells in *PV-1*, after the ageing process (106 thermal cycles), showing: 1. distorted busbars 2. brown EVA discolorations and 3. cyan coating discolorations

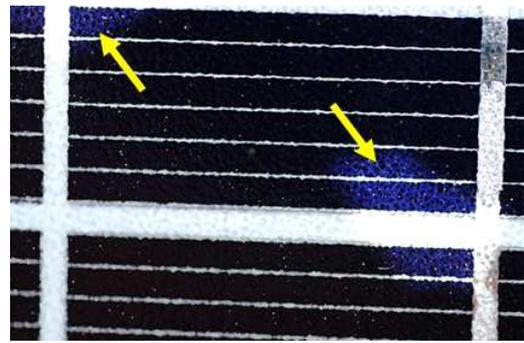
Fig. 10. Optical microscopy image of defective cells in *PV-3*, after the ageing process (106 thermal cycles), showing cyan coating discolorations.
