Evaluation of long term degradation process of monocrystalline Si photovoltaic panels

Abstract. The paper focuses on evaluation of long time degradation process of the oldest grid-on operated photovoltaic system in Czech Republic.

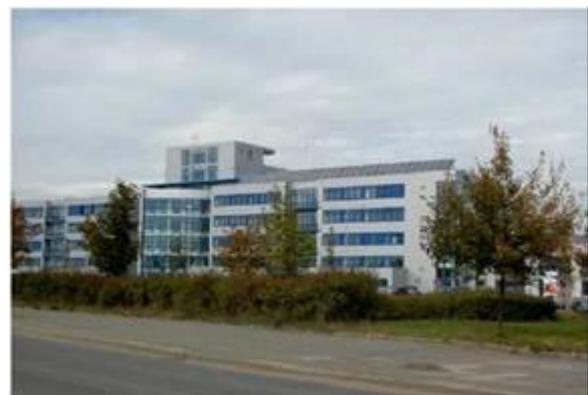
Fig. 1. General view of the experimental 20 kWp PV plant

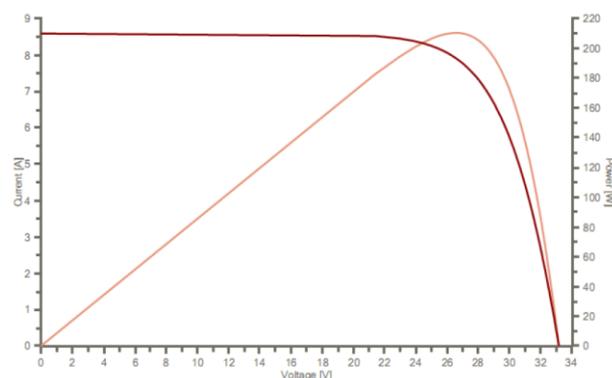
All panels were disconnected from particular strings and individually measured with VA characteristic analyser HT Solar IV-400. Sample VA and power characteristics of healthy panel are shown on Fig. 3 (panel 1, 2013). Example from 2013 is selected, because these measurements has detected first malfunctions.

Fig. 3. Sample characteristic of panel 1 (2013)
