Solar Panels for Auger Southern Observatory: “SPIDERSHADOWS”

Abstract. During the winter of 2009, technicians inform about how during a visual inspection they detect failures in the surface of different solar panels. The inspection was not casual, but due to problems with the level of charge of the batteries. Because of the aspect on the failure we will name it “spiders” (*arañitas*). But other anomalies, associated to the expected ageing, have been observed, like panels with blued cells, browed surface and others. In the present note, we will describe each of the observed failures, their possible causes and their effect on the solar panel operation. The full data sample we used has been obtained either on dedicated laboratory test (PAO, USC, CIEMAT) or by direct measurement in the field.

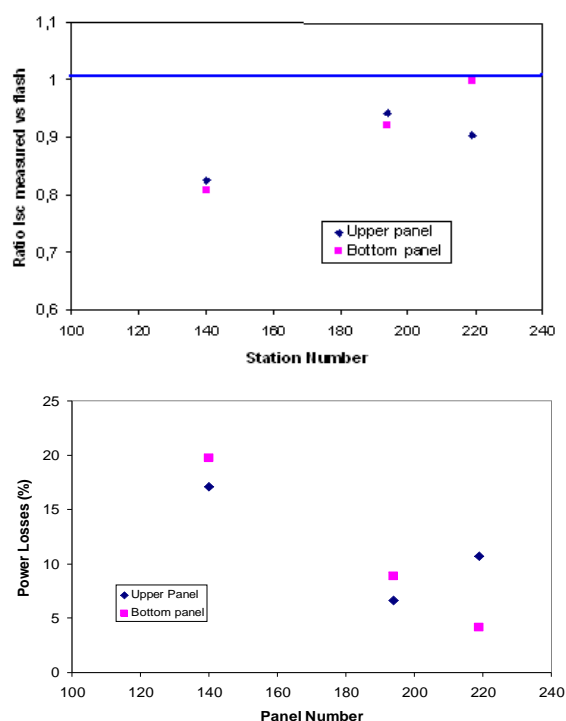
In order to evaluate the actual degree of degradation on the different panels tested, we study the ratio between the measured short-circuit current, normalised to 1000 W/m², for these solar modules and the corresponding own values given by the manufacturer in their monitoring flash. Remember that these monitoring flash values and their reliability have been checked before installation. Fig. 4 shows the observed results.

losses, equivalent to around 19%. One of the observed spider is the one higher in size.

- The *station Gladis 194*, with several spiders, shows losses close to 10%. As main remark, visual inspection tells that the bottom panel of this station is the one with more number of spiders (17), even if smaller. The lower loss of current observed, suggests that is the size of the highest spider in one module, and not the number of them, the dominant effect. It is plausible since the cell with less current determines that of the others and thus the solar panel performance.
- *Station Federico 219*: Upper module, with some observed failures, even if no spiders, presents losses close to smaller and compatibles with the calibration uncertainties, temperature dependence and others.

Fig. 4: On the top, the ratio between short-circuit currents corresponding to the solar modules of three Auger visited stations vs station number (Moulin 140, Gladis 194 and Federico 219). In blue the upper panel and in pink the bottom one. On the bottom, the percentage of observed losses

The power loss plot ratifies, as in some way expected, the previous results. Power is calculated as the product of the short-circuit current and the panel voltage in open-circuit, weighted with flash measurements shape factor. As an initial assumption, we consider that open-circuit voltage is not dependent on irradiation. The obtained values show how the panels with spiders present associated power losses between 10% (Gladis 194) and 20% (Moulin 140). The observed 2.5% power losses correspond to the expected panel ageing.

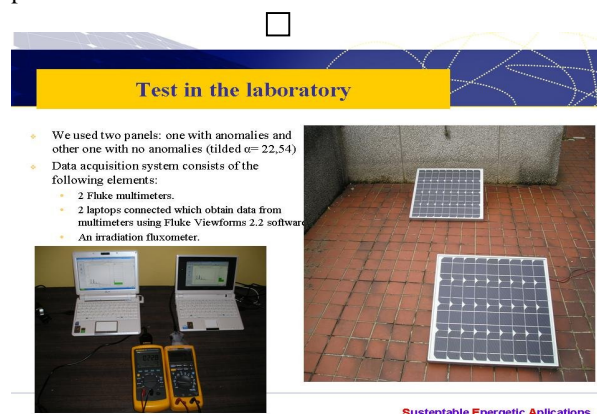
Fig. 5. Photographs of experimental set-up in the laboratory test.

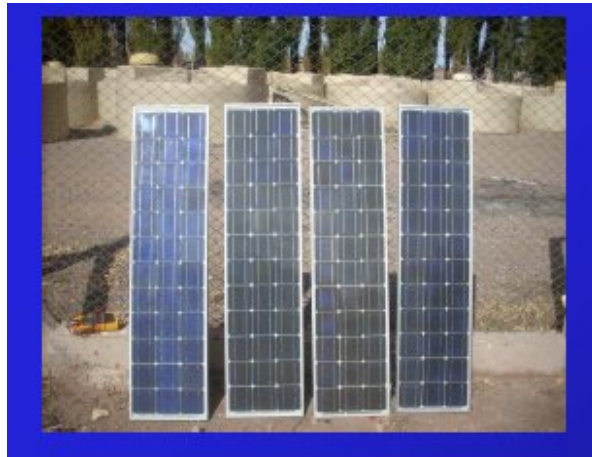
- 1) *Measurements at experimental hall, in PAO:* Panels representing the bulk of all detected anomalies, blue cells, surfaces with brown deterioration, and spiders in its different versions, were selected and tested as a whole in the own hall of the PAO. In photograph 6, this simple experimental setup is shown. From left to the right, a solar module with blue cells, a browned and spider one, a spiders one and a panel without apparent failures used as a reference. In this case, the reference module has been used for radiometer calibration (see on the left).

Fig. 6. The four solar modules studied at PAO's assembly building

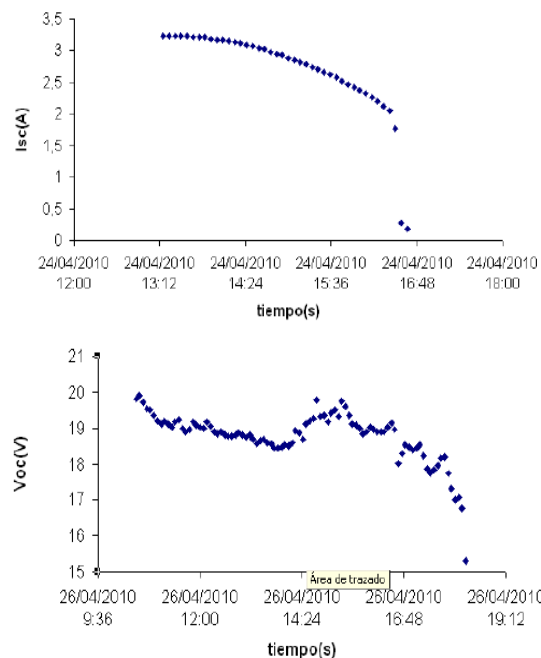
Fig. 7 shows the characteristic values throughout a complete day both in short-circuit current and open-circuit voltage of the reference panel. Unfortunately,

temperature was not controlled during the test, but its influence both in short-circuits current and open-circuit voltage could be considered as negligible. Open-circuit voltage dependence with irradiation is not present -see Fig. 7-, so only short-circuit current will be analysed in the following.

Fig. 7. up: short-circuit current in time for spider case. Bottom: the same for open-circuit voltage.

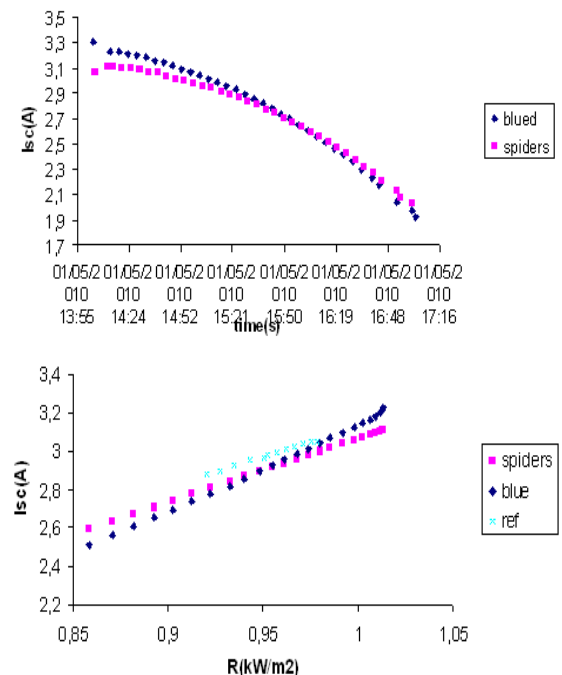
Fig. 8 resumes the main obtained results: On the left, a blue and a pure spider panel are compared. The first remarks is how the differences increases with the short-circuit current. To clarify the point, on the left, the variable is plotted versus the measured irradiation. Under 960W/m^2 , blue solar module present lower values of short-circuit current than the module with spiders does

Fig. 8. Up: short-circuit current in time for blue (blue dots) and spider modules. Right: short circuit current with respect to irradiation for blue (blue dots), spider one day (pink) and reference one.

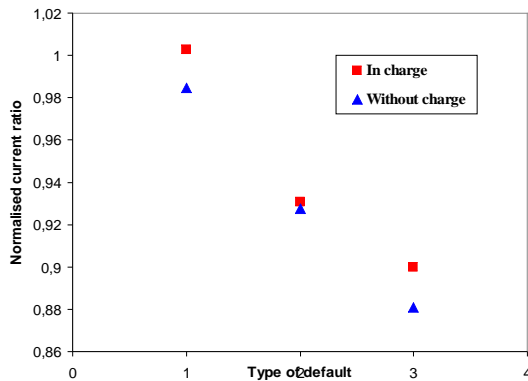
In Fig. 9, we show a comparison between the tendencies measured for the panels currents and voltages both in, respectively, short-circuit and open-circuit voltages as

well as with the described charge connected. In spite of the fact that the irradiance and temperature could not be absolutely controlled, the tendencies look considerably similar. The corresponding set of power values that can be obtained from the data are as well expectable and compatible with short-circuit current and open-circuit voltage measurements. In this way, we could state from the carried out measurements that for this kind of anomaly short-circuit current and open-circuit voltages are in general representative, sensitive and useful magnitudes which values could be easily extracted in the field by technicians during the normal station checks.

Fig. 9: Normalised short-circuit current with respect to reference's versus the type of anomaly: 1 blue, 2 brown, 3 spider for the solar module with a charge (red) and without it.

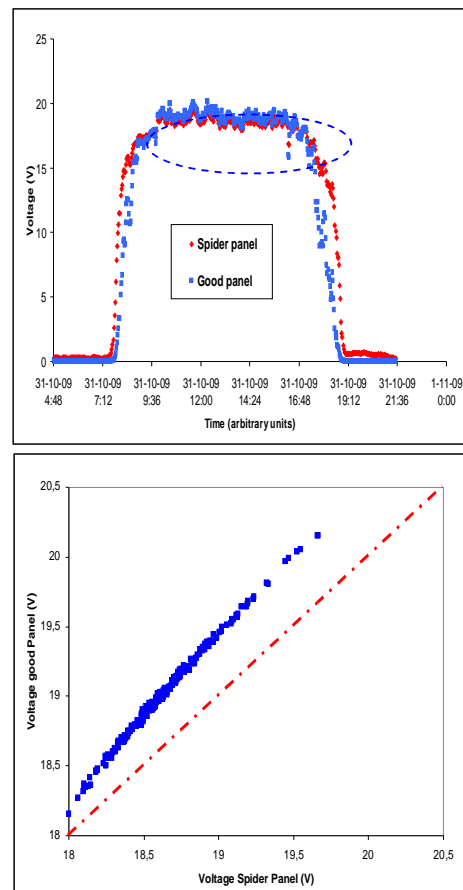
1) *Measurements at the lab of Santiago of Compostela*: The same outdoor protocol, but in a more exhaustive way, was implemented at the laboratory of Santiago de Compostela. Unfortunately, because of our meteorological conditions, only low irradiation level can be studied. In this case, we focused our study on the first panel in which the spiders were detected: The upper panel installed on the station Ezequiel, 102, with seven spiders (see fig. 2). A reference module ("patron") calibrated both in behaviour and irradiation [2], has been used for comparison. In this case, a parallel measurement of irradiation becomes unnecessary. Fig. 10. shows the open-circuit voltage during a day. On the left we show the scatter plot of open-circuit voltage for both panels during the central hours of the day, in order to avoid temporary problems related to low irradiation. Notice that spider case presents, systematically losses in voltage. Fig. 11 shows the short-circuit current behaviour through the course of a day. Results are compatible with the obtained in the test carried out at PAO : Under low levels of irradiation, both panels show a similar behaviour, whereas at the highest values of irradiation, spider module shows values up to 10 % smaller on the peak. Integrating along the full day we can assume that losses varied between 5 % and 8%, unfortunately depending on the irradiation level.

Fig. 10. Voltages of spider panel and calibrated one vs time. In the upper part, open-circuit voltage in spider case versus the same in calibrated panel.

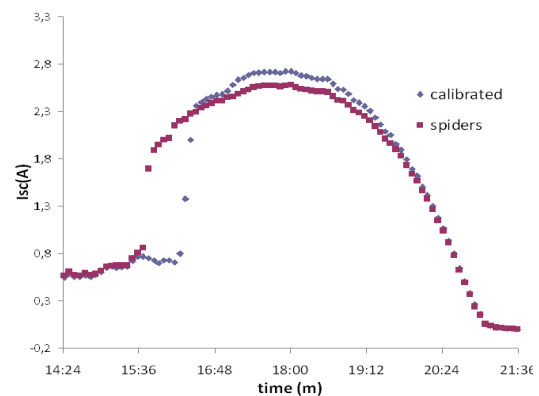
Fig. 11: short-circuit current vs time for spider panel (red) and calibrated one. It is worth noting that the differences in behaviour between 15:30 and 16:30 should not be taken into account since they are caused by an unavoidable, but controlled, shadow.

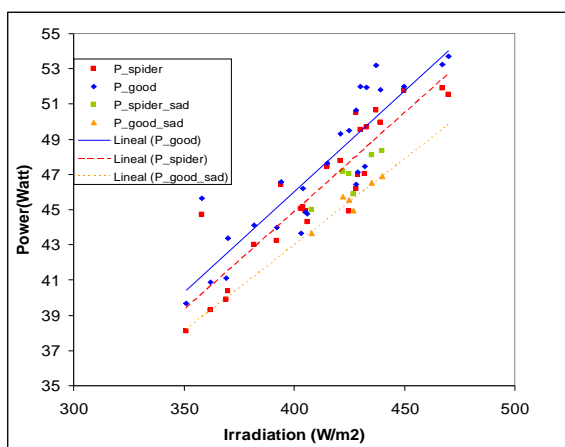
The results obtained in our measurements in the Malargüe experimental hall suggest as a hypothesis that the effect of the spiders on the panel performance is dominated by the size of biggest spider on it and not by the number of them in the solar panel. In other words, it looks like if the surface occupied by the spider “shadow” the cell, producing the corresponding decrease on efficiency. To evaluate this possibility we perform a simple set of measurement on the USC lab:

Fig. 12: Power of the solar panel vs irradiation. Reference panel with (orange) and without (blue) cover. Spider panel with (green) and without (red) cover.

Fig. 12 shows the obtained results. When one of the cells of the reference panel is partially covered, the power decreases about 10% at 450 W/m². At the same irradiation level, power decreases less than 3% when the fissured cell is covered on the spider panel. That is, if the surface of the cell with fissures is blocked up, there is only a small effect with respect to the same action effectuated over the normal panel. This suggests that the spider cell is less sensible and the losses in power are proportional to the spider surface.

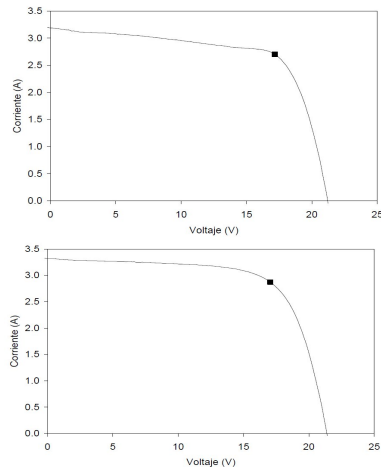
In Fig. 14, the characteristic curves of both solar panels are shown. There is a noticeably different shape between them, since spider case has a slightly more irregular shape than that of the calibrated one, as well as lower current values. The corresponding main parameters for

each case are shown in Table 2, where spider solar module has a current with respect to that of the calibrated panel of around -3.27% whereas -5.11% at maximum power regime.

Fig. 14. Characteristic curves for spider case (up) and calibrated one.
