PV power stations – fire hotbeds and fire tolls

Abstract. This article deals with photovoltaic power stations acting as possible fire hotbeds and simultaneously fire tolls. Main PV features defining fire risks of alone standing or on building mounted power station are discussed. Analyses described in main chapter are based on real case of a lightning strike. Divergence between direct lightning strike and close lightning strike is deeply illustrated and possible protections are discussed. Following paragraphs deal with fire rating and fire performance of particular PV panels, relevant dangers for acting firemen, extinguishing ways, particular fire progress and secondary hazards. The problematic is demonstrated on the base of experimental photovoltaic plant fire and real examples of injured panels.

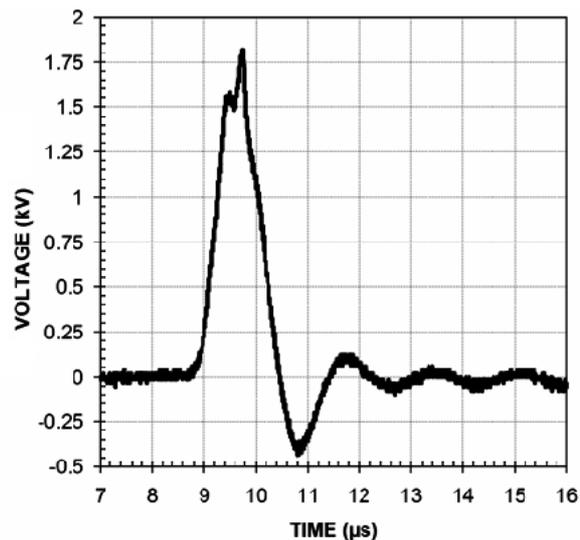
Fig. 5. Sample pulse 2 kV (EM Test VCS 500).

Sample waveform printscreen of generated HV pulses for $U_p = 2$ kV is demonstrated on Fig. 5.

Because no evident influence was detected, the panel was connected to 8 stage HV generator Heafely capable to simulate atmospherical pulses 1,2/50 µs up to 600 kV. Table 3 illustrates panel status after particular tests.

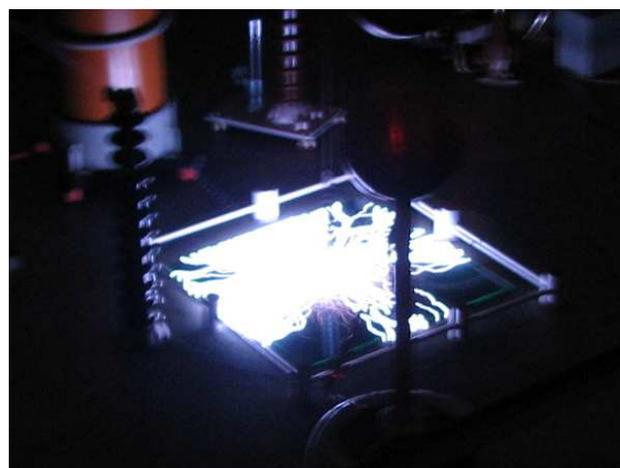
Fig. 6. Sample pulse 600 kV (Heafely generator).

Table 2 and Table 3 show that no measurable panel damage was detected on VA characteristics. That could be explained with insufficient energy of generated pulses although the discharges produced very dramatic visual effects as demonstrated on Fig. 6.

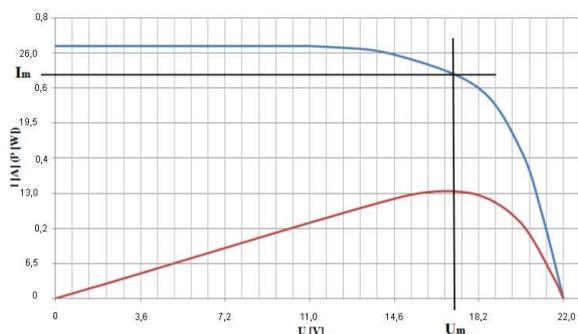
Fig. 7. VA characteristic after all tests.

Sample VA and power characteristic after all measurements is displayed on Fig. 7. No deformation similar to Fig. 4 is evident and the values are proper to

nominal listed in Table 2. Also no visual damage similar to Fig. 2 was detected.

Demonstration discharges did not simulate direct lightning strike with proper results.

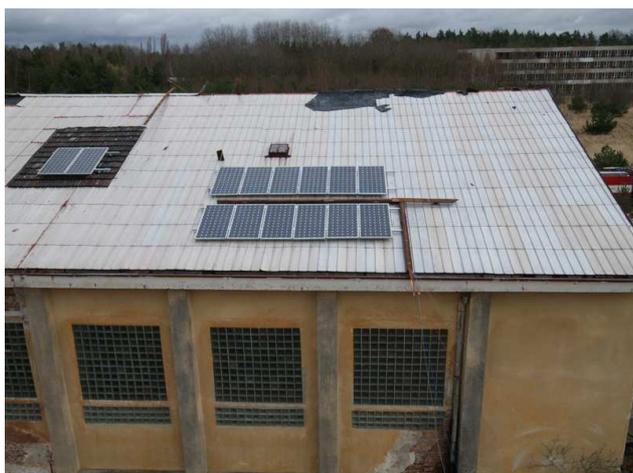
Fig. 8. Experimental PV plant configuration.

Experimental PV plant was built on the roof of an old military building determined to be demolished. Configuration of the experimental plant on the building roof is displayed on Fig. 8.

Special additional measure lines were designed and thermally shielded in wooden canals to acquire relevant data during the fire. Panel temperatures, output voltage and current, VA characteristic and thermographs were measured periodically.

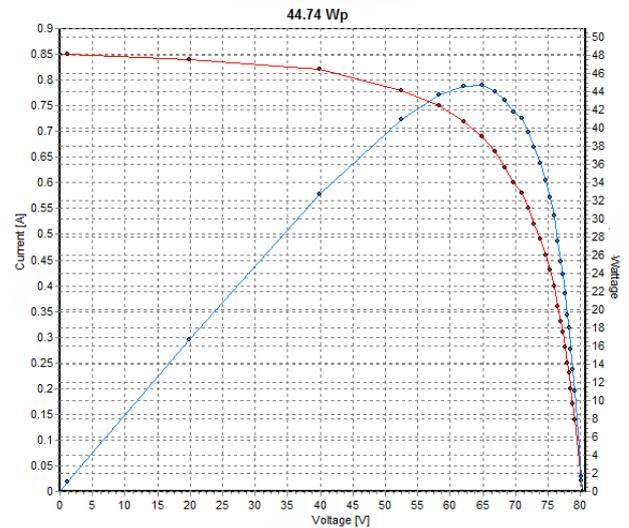
Fig. 11. Sample VA characteristic (time 0:00 min)

Measured VA and power characteristics of string 1 during the fire are presented on Fig. 11, Fig. 12 and Fig. 13. The partial power decrease on Fig. 12 can be explained with smoke shading the panels, while Fig. 13 shows zero output of damaged string.
