The effect of surface impurities on photovoltaic panels

L. Dorobantu, M.O. Popescu, Cl. Popescu, A. Craciunescu

Electrical Engineering Faculty
POLITEHNICA University of Bucharest
313 Independentei, 060042 Bucharest, Romania, Tel/Fax : +040 213181003
loredana.dorobantu@upb.ro; mo_popescu@rectorat.pub.ro; claudia.popescu@upb.ro

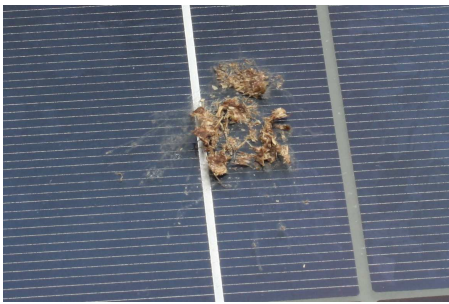
Fig. 2. The real image of the deposition on the panel surface

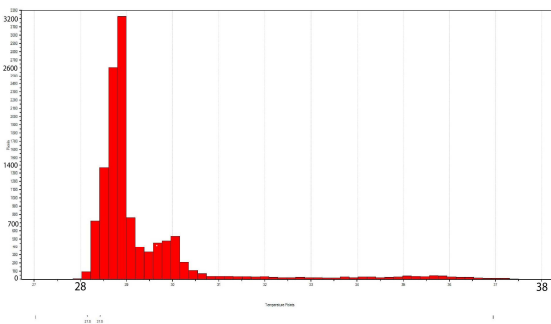
value recorded of the temperature is 37.5 °C, which occurs in areas where deposits were dense.

Fig. 3. The histogram of the picture taken with the thermo-vision camera for the area of the panel that contains the deposition

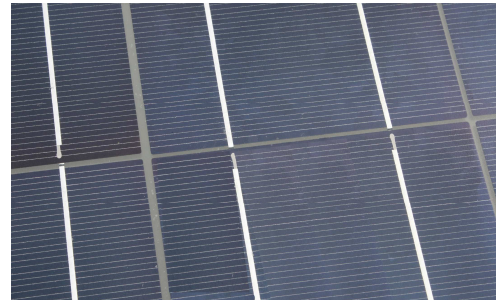
Fig. 5. Real image of the first clean panel

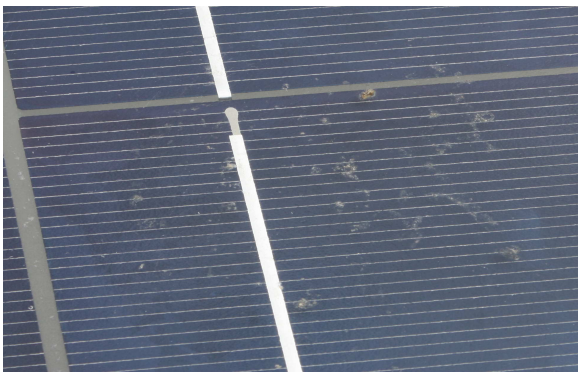
Fig.8 Real image of a less consistent deposit on a photovoltaic panel

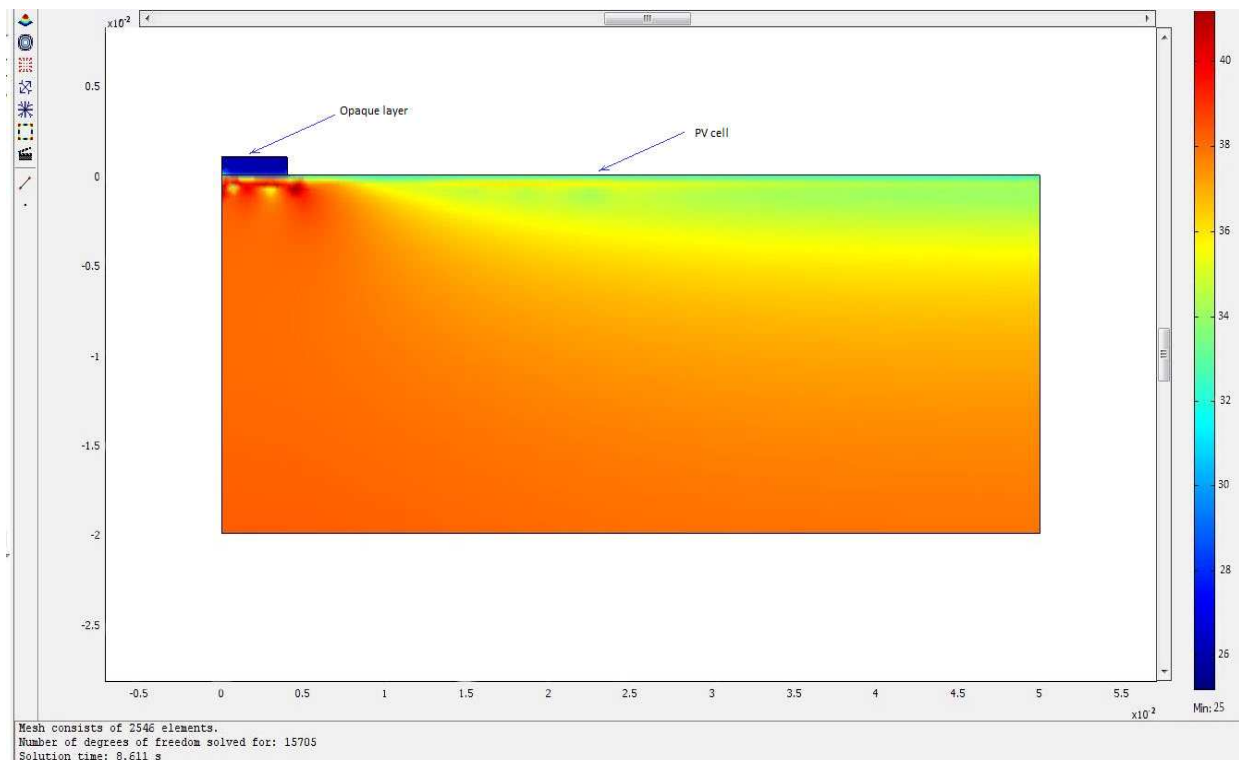
To get a clear picture on the negative effects of depositions on photosensitive surfaces, simulation of a solar cell was realized in the software environment Comsol Multiphysics. A part of the cell area was covered by an opaque layer, creating thus an artificial surface defect. The model created was bidimensional (2D), in order to monitor the evolution of the temperature of the panel in cross-section view.

To solve the problem, existing modules were used in Comsol Multiphysics: Conductive Media and Electrostatics. In figure 12, the temperature evolution of a cell having an artificially imposed defect is shown in cross section.

The opaque layer from the simulated model corresponds to the deposition on the photovoltaic cell, causing warmer areas around it. Thus, the shadowed part of the cell determines power drops and can vary depending on how the deposit is located on photovoltaic cells. The power loss increases considerably if the deposit affects many cells grouped in parallel, the effect being an introduction of a large impedance, simulating an open circuit. [3]

Fig.12. The conduction of the heat within the covered cell (cross section)- model realized in Comsol Multiphysics

Values of the temperature are very close to those measured with the thermo-vision camera, after the simulation. Next to the deposit, the highest values are reached, which finally affect the entire cell, as the simulation shows. These increased values of the impedance of the cells from the deposit area consist of Joule losses for the entire panel.
